# Confidential Inspection Report

LOCATED AT:  
3200 Larissa Dr.  
Los Angeles, CA 90026

INSPECTED ON:  
Wednesday, September 5, 2018

Inspector, Joe Bass  
Bass Building Inspection, Inc.

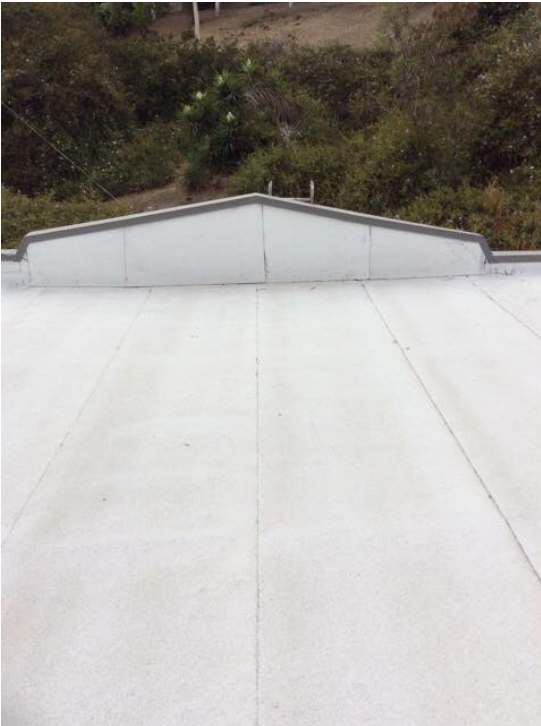
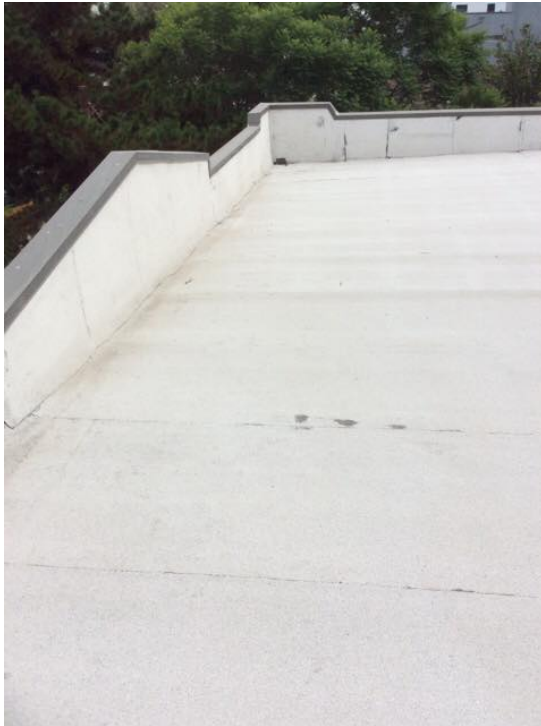
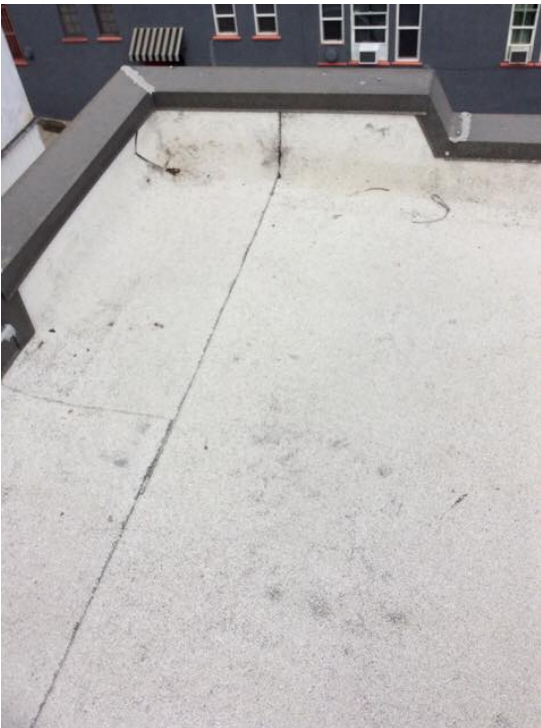
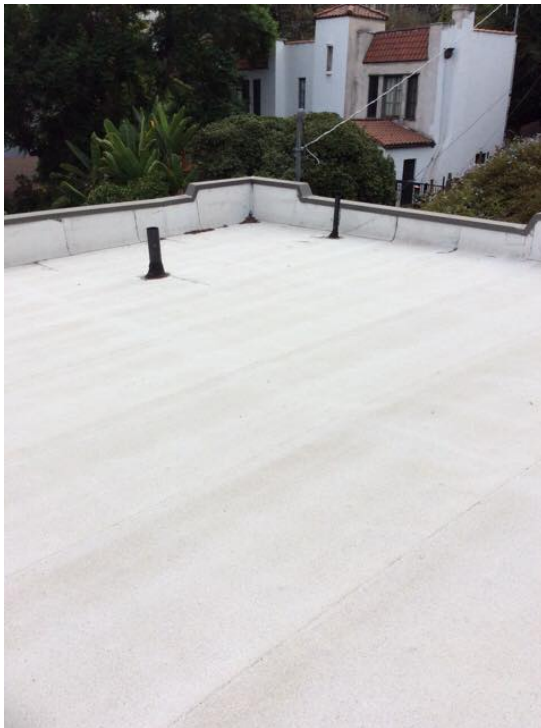
**30:** - The roofing surface appears to have been properly installed and is in serviceable condition. The typical service life for new cap sheet roofing is approximately 15 years. Along with attention to the items noted and routine maintenance the roof should remain watertight for a number of years. See the comments below for further remarks.

**31:** - It is recommended that the cap sheet is coated with a paint substance that is intended to improve its service life, waterproofing and efficiency.

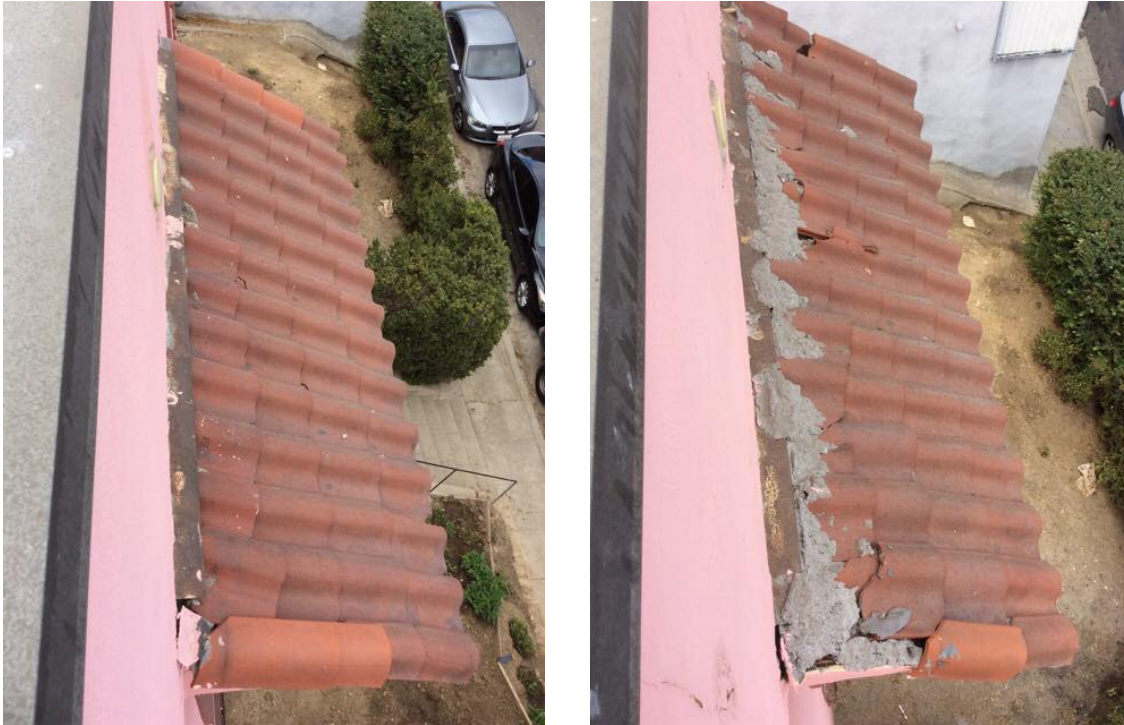
**32:** - The two small sections of tile roofing at the north wall are in poor condition. Cracked, loose and damaged tiles are observed. Repair replacement is needed.

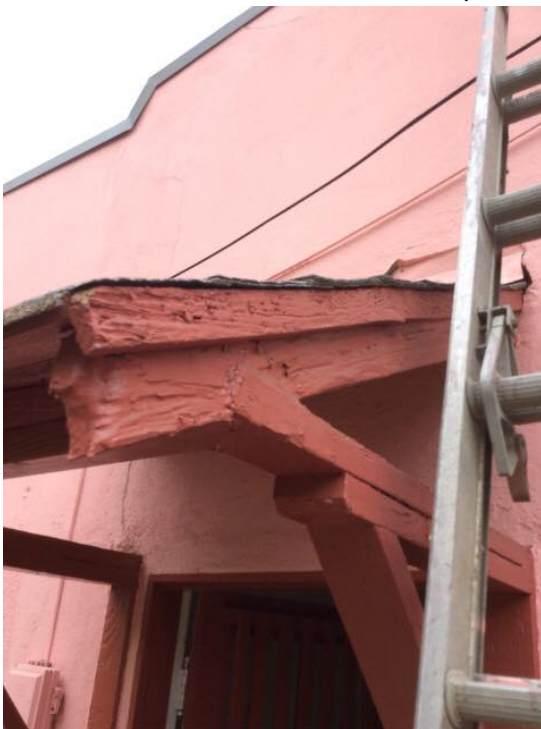
**33:** - The composition shingle materials installed of the two small porch coverings at the south wall are in serviceable condition. However suspect wood degradation is observed at the framing.

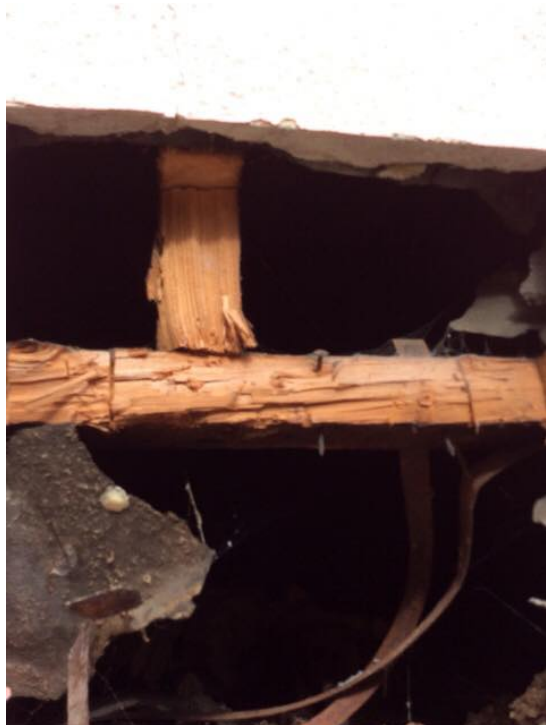
**47:** - The framing near the south wall vent and access opening is deteriorated and/or damaged. A termite inspector should be consulted for a further examination, recommendations and repair.

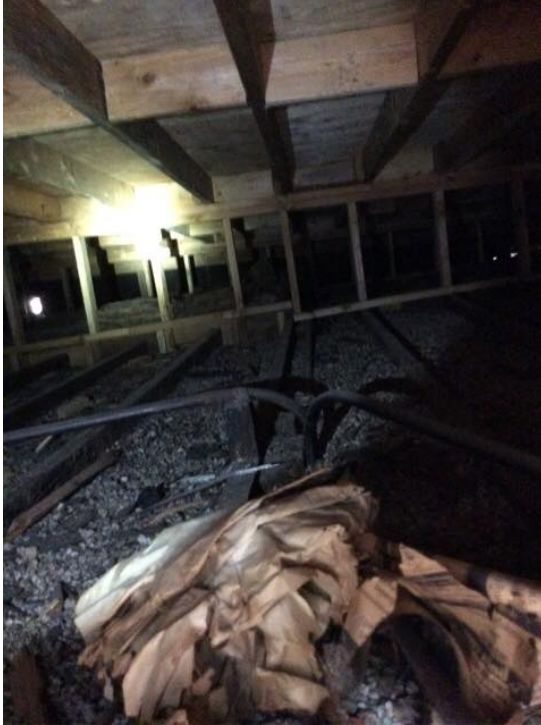
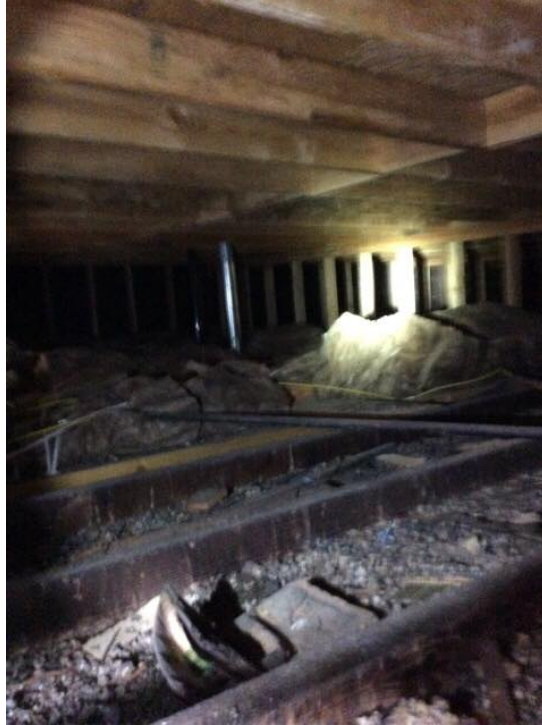
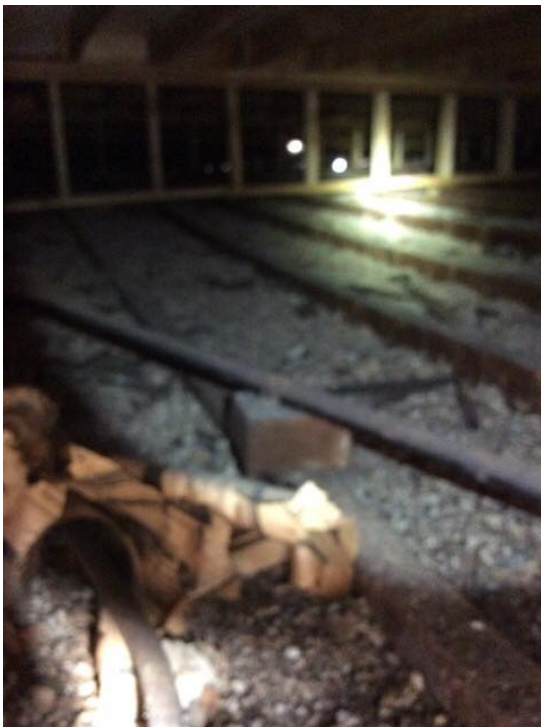
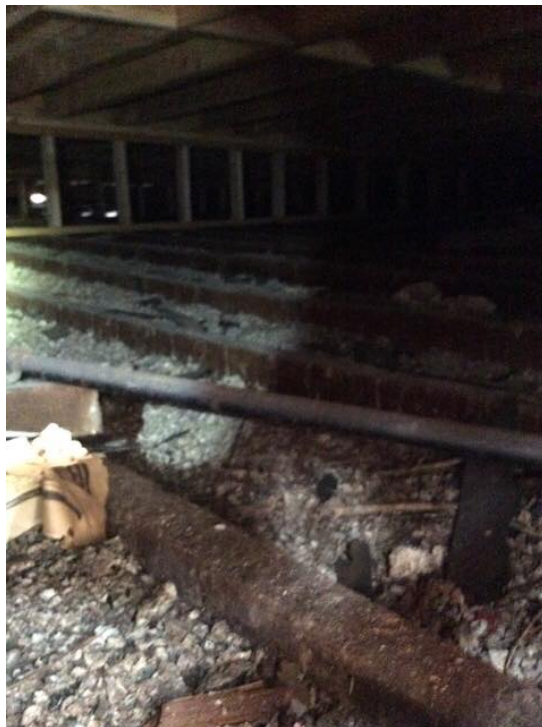
**50:** - We observed a unusual amount of bird droppings and nesting materials throughout the attic floor (approximately 2 to 4 inches high in areas). This is a significance health/safety concern. Additionally there is an additional load concern on the ceiling structure above the interior living space. We recommend a specialized contractor who is familiar with this issue be consulted at this time for further examination, recommendations and removal of the droppings and debris. The vents should be screened to limit future habitation.

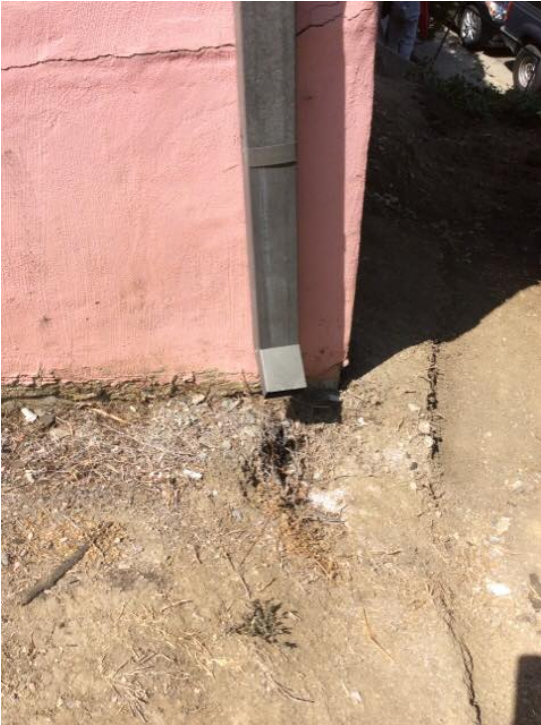
**63:** - The downspouts that terminate within the planters and adjacent the foundation walls is substandard. It is recommended that the downspouts be extended for improved area drainage.

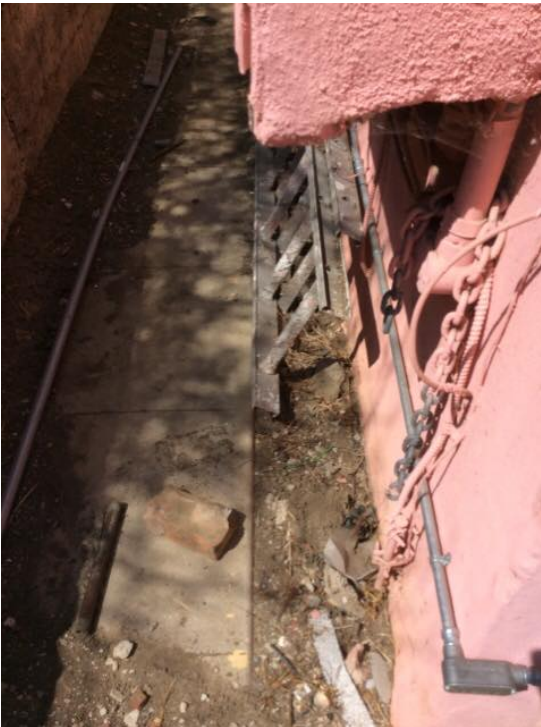
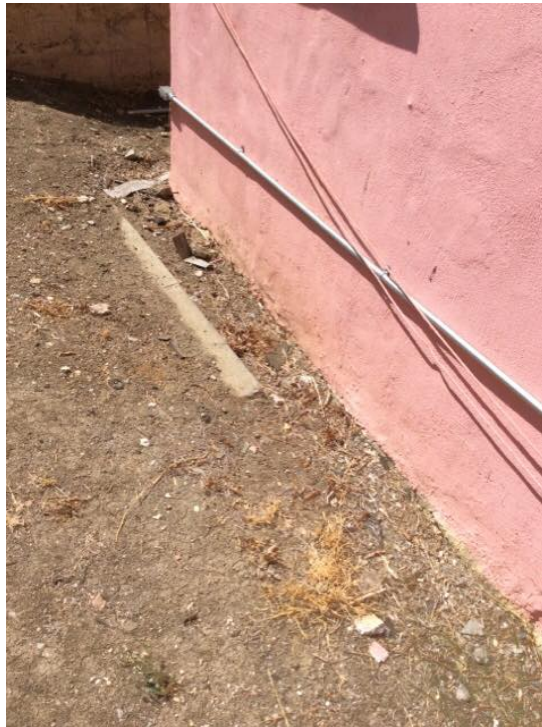
**64:** - Grading is flat or sloped toward the structure in some areas. Low spots and negative grading promote water accumulation near the building, leading to foundation problems. Regrading is recommended to ensure that surface water flows away from the structure.

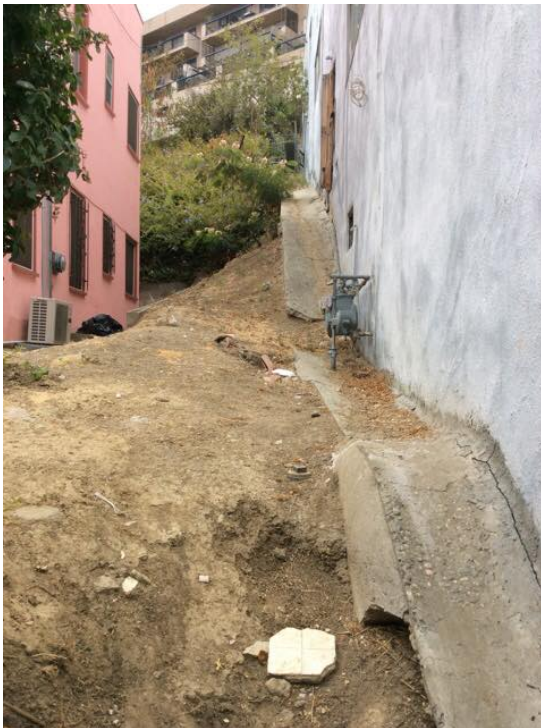
**69:** - It is our opinion that the existing surface drainage is insufficient. It is also noted that the drainage for the adjacent building directed towards the subject building. We recommend that upgrades to the sites drainage be undertaken.

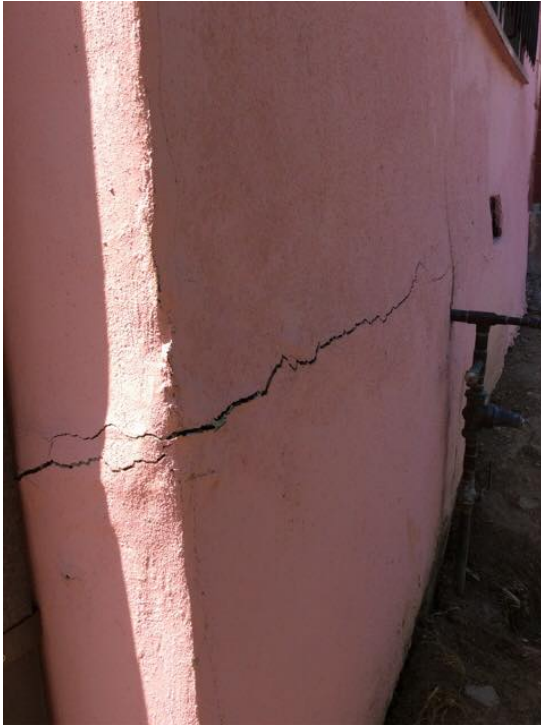
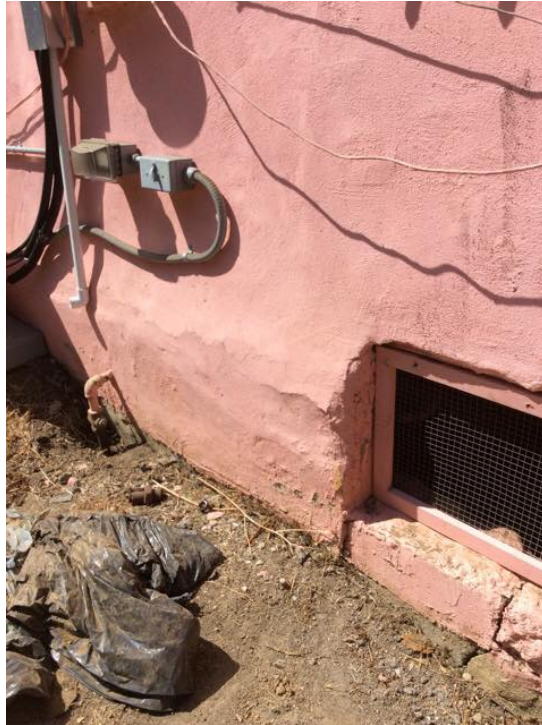
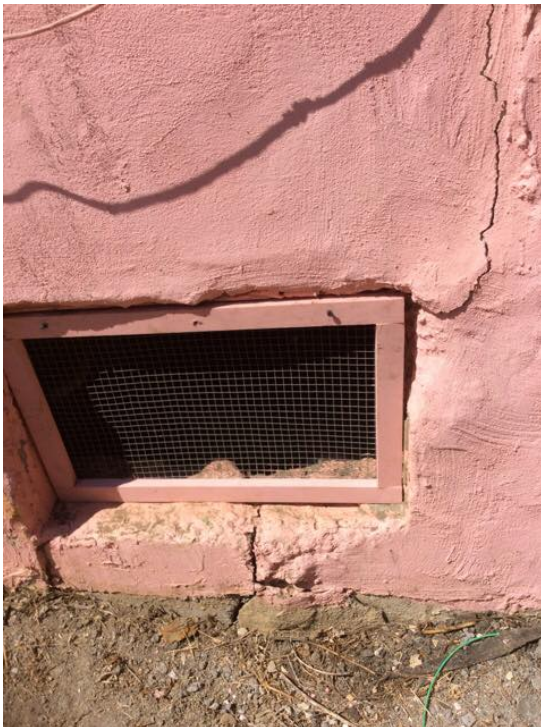
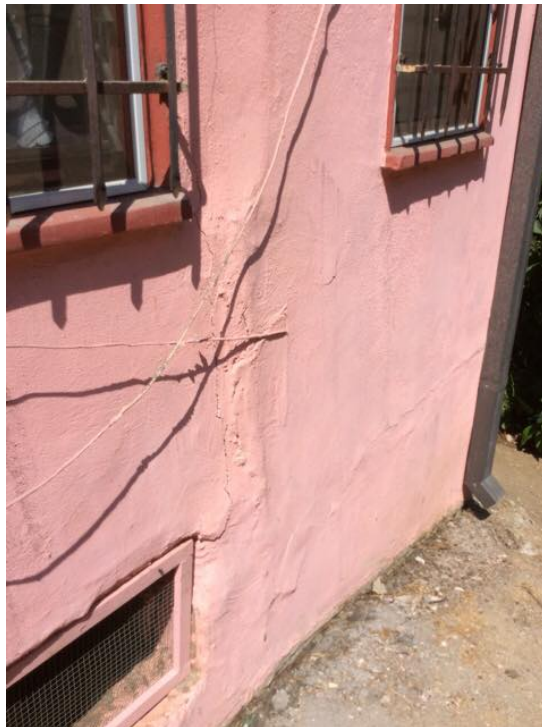
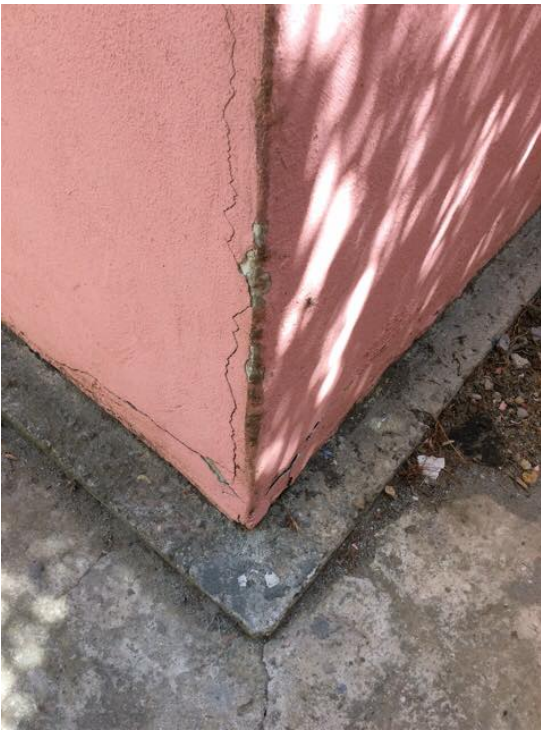
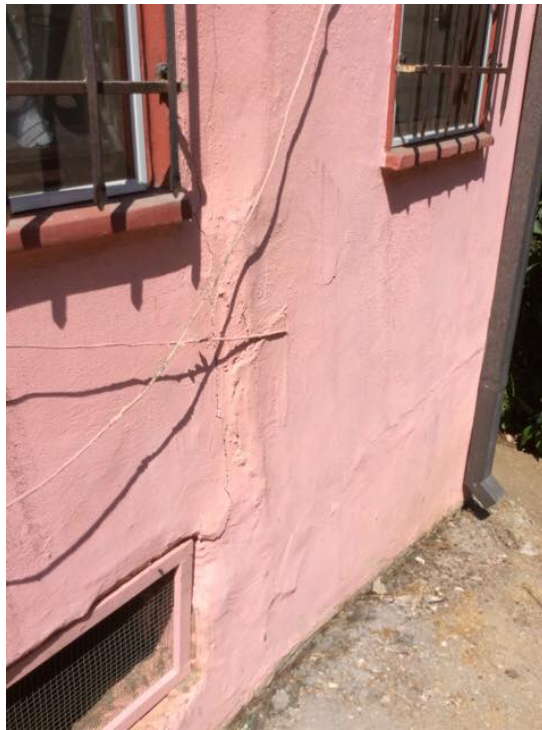
**74:** - There is cracked stucco indicating movement at the foundation. These surfaces can be patched, but if movement in the structure is not addressed, the cracks may return and/or become more noticeable.

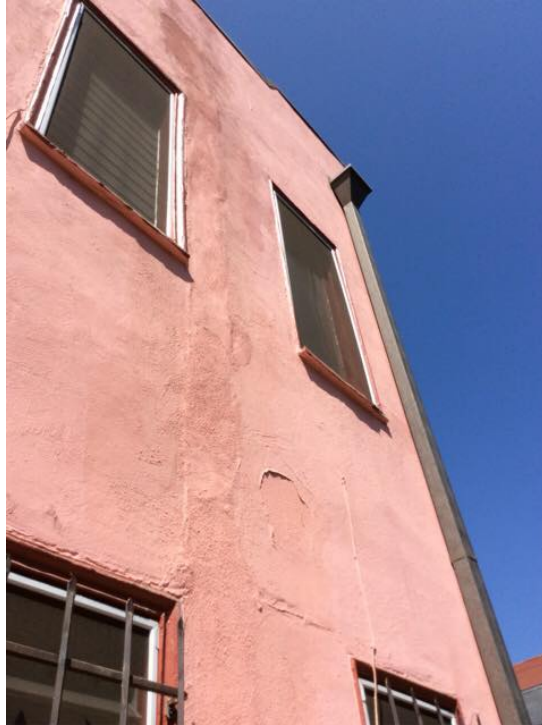
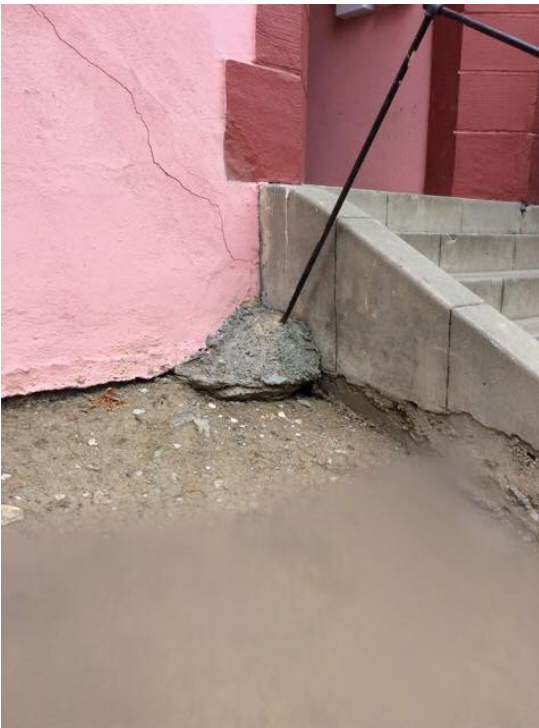
**75:** - Portions of the exterior appear recently painted. Numerous cracks and repaired areas are noted at the stucco throughout the building. As with any recently refinished and freshly painted surface, the stucco may have conditions present that were not readily apparent at the time of our inspection. We do not suggest that this inspection has identified all such conditions.

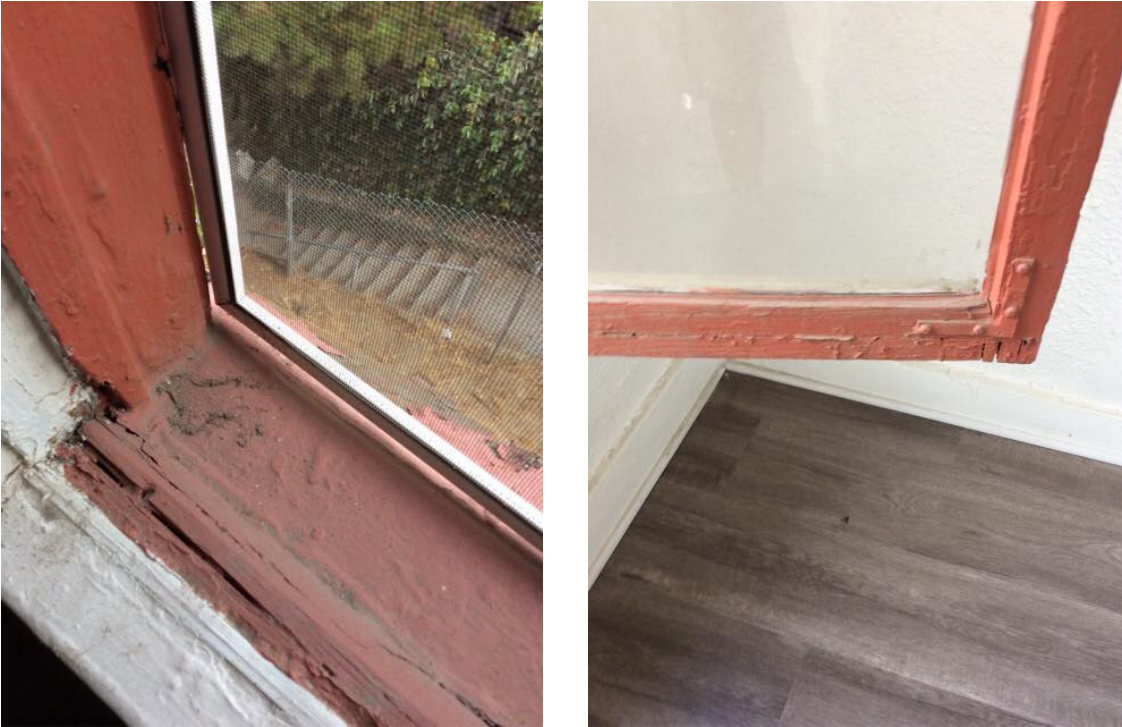
**81:** - Many windows are deteriorated or damaged. We recommend they be detailed, repaired and/or replaced. A termite inspector should be consulted for a further examination and recommendations.

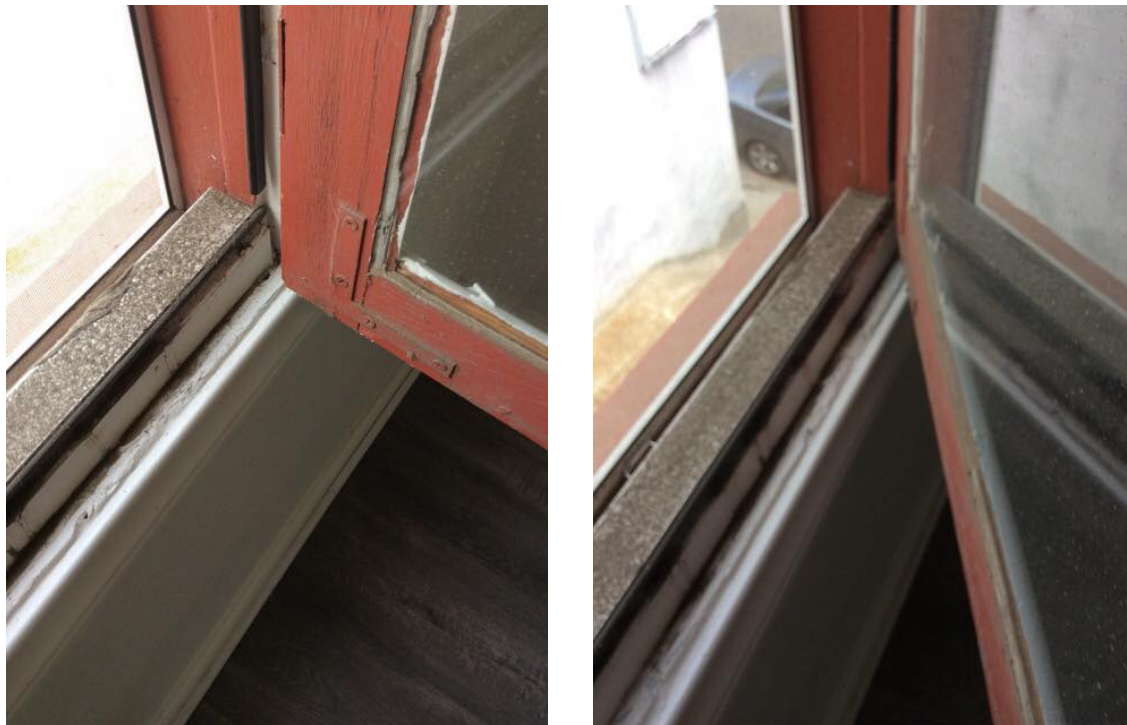
**84:** - Drip flashings are missing at some of the hinged windows. Installation drip flashings is recommended to prevent water accumulation and intrusion.

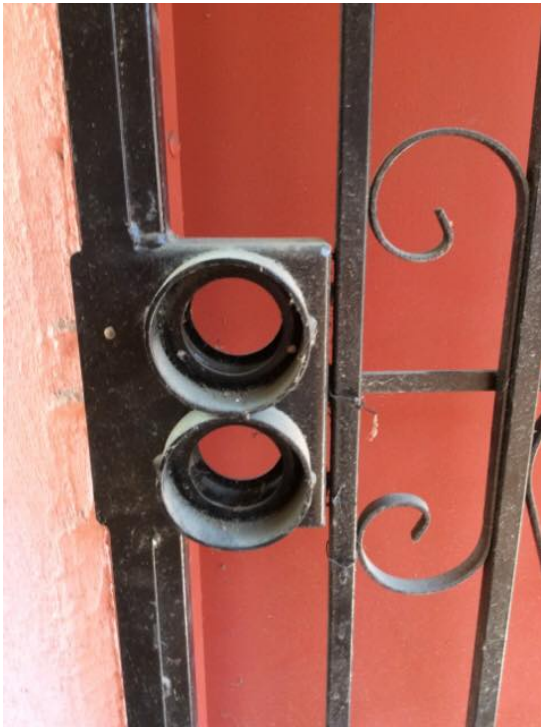
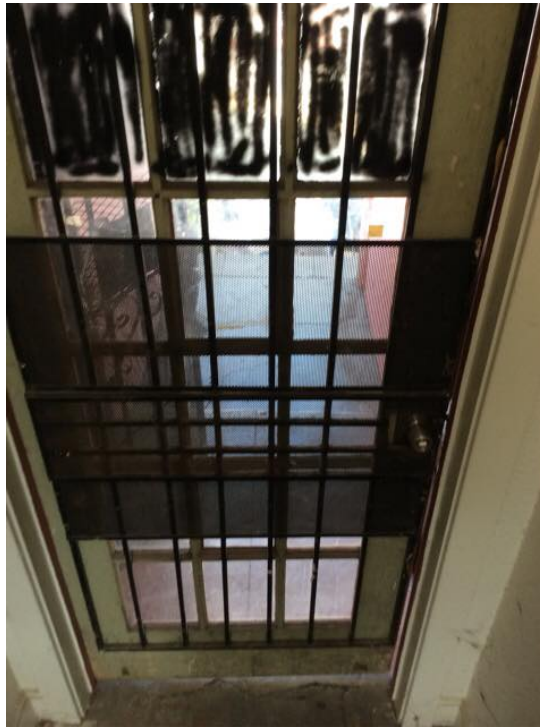
**86:** - The knob and lock assembly at the lower south door is missing. Damage is also noted at the entry doors.

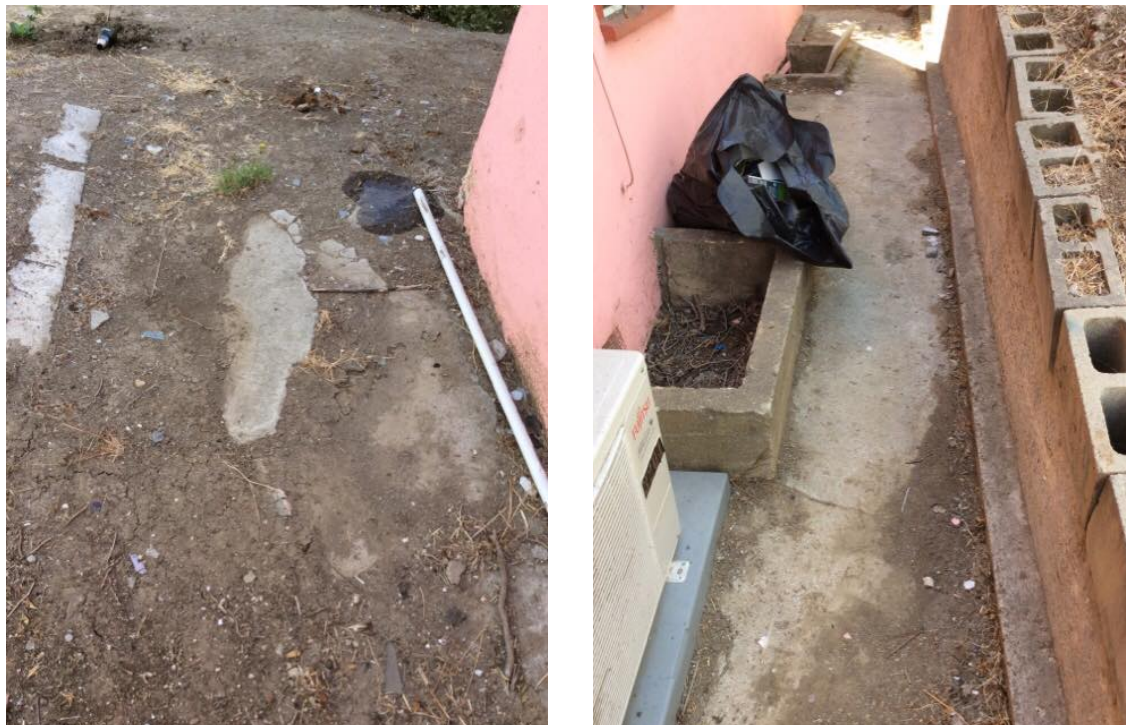
**89:** - There are trip hazards in the walkways. We recommend they be patched or repaired to prevent injury.

**90:** - There are significant cracks in the walkways. We recommend the walkways be replaced to restore their appearance and safety.

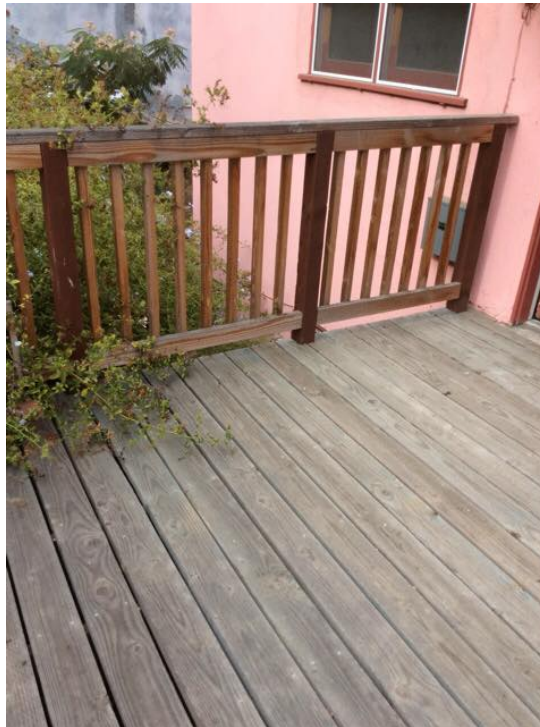
97: - The dimensions of the hand and guardrails at the stairways and balconies do not comply with current standards. The conditions may be permissible under the "Grandfather Clause". However installation of conforming hand and guard rail systems should be considered.

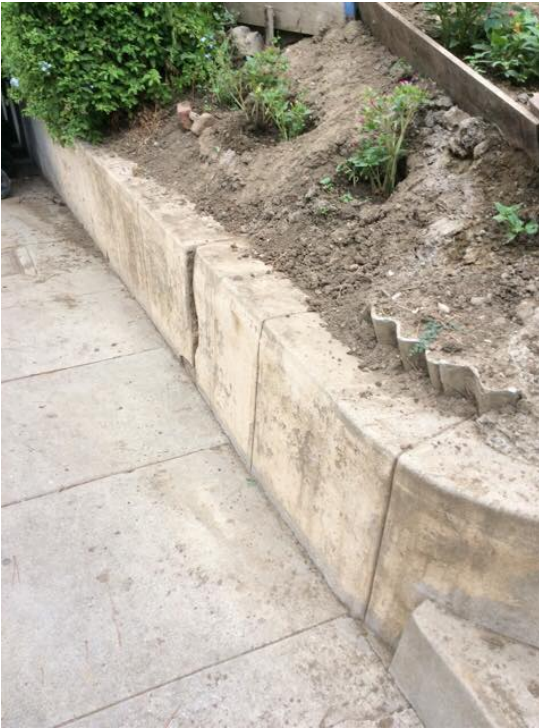
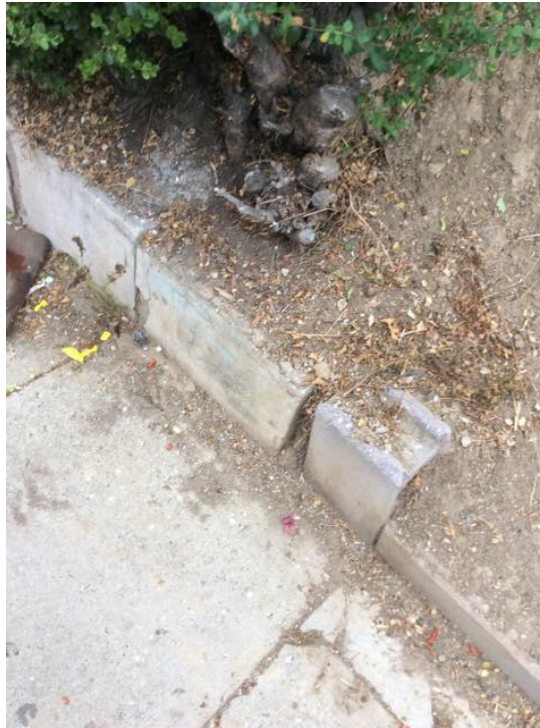
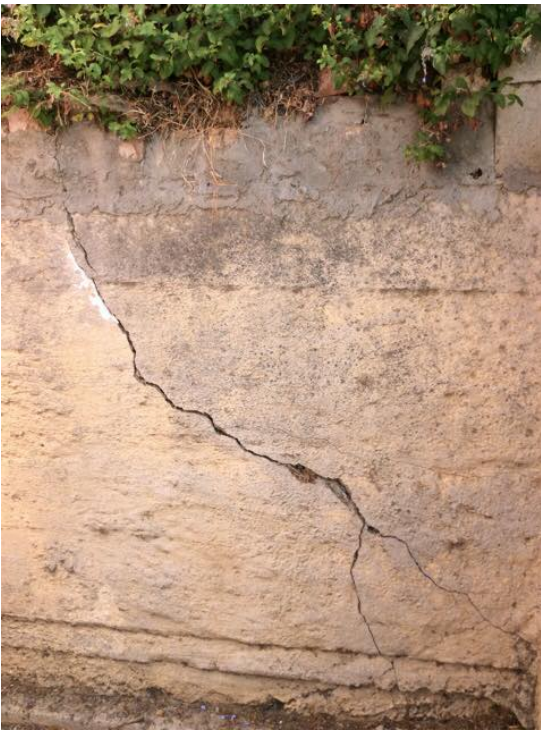
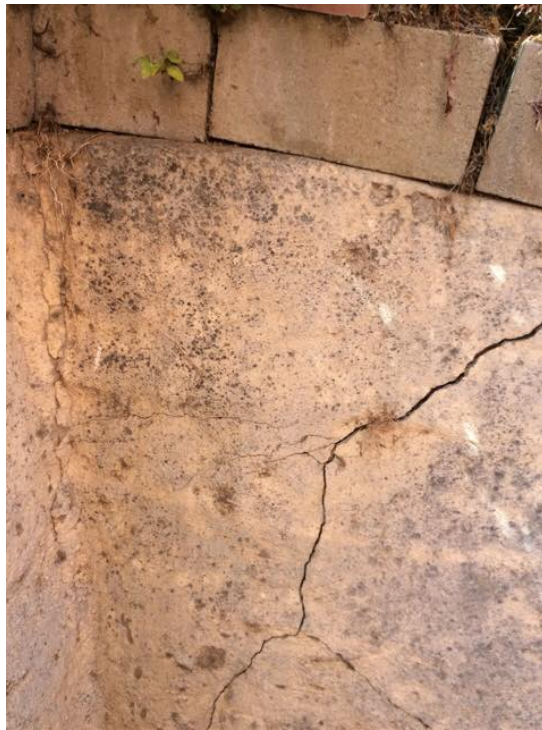
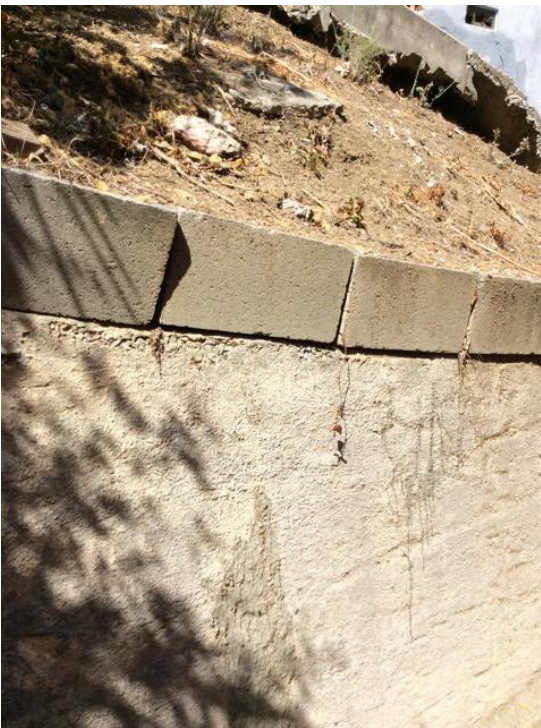
**99:** - Retaining walls, yard walls, fences and gates are not within the scope of the inspection. However some comments are given as a courtesy and for a better understanding of the property. The fences and gates generally appear serviceable at this time. Sections of the walls throughout the grounds are cracked and displaced. The source/significance is not determined. Soil build up from apparent surface erosion is also noted at some of the walls. Bricks have been loosely placed above some of the walls. Consult the owner regarding the circumstances.

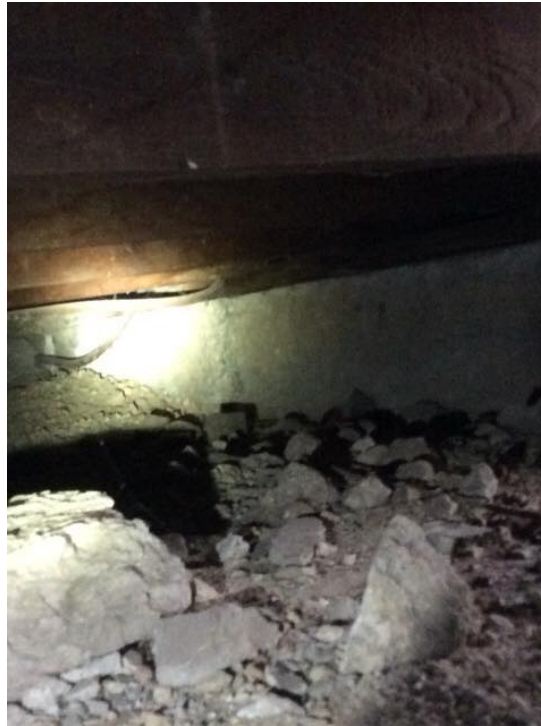
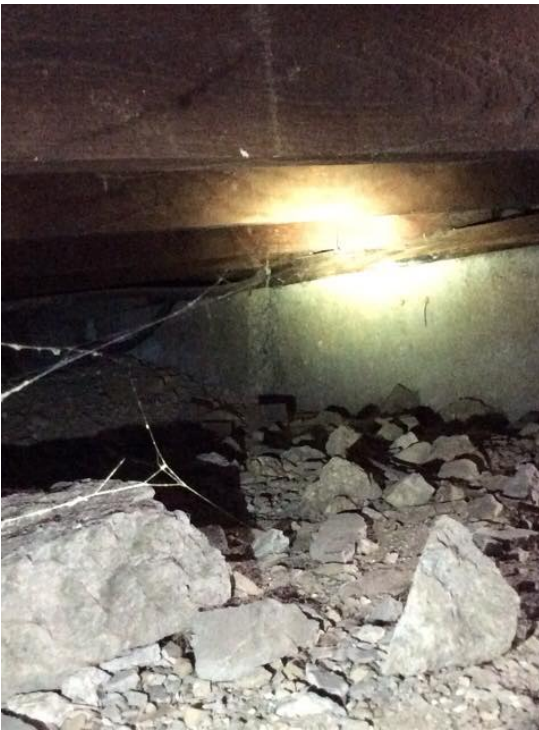
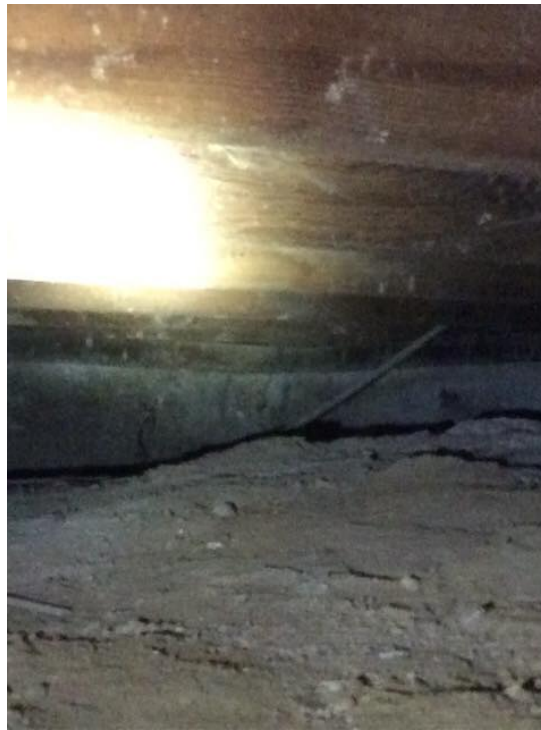
**113:** - Approximately 4-6 expansive cracks and significant displacement is observed at the concrete stem walls. The source/significance is not determined. The need for significant repairs or replacement of the damaged portions of the foundation stemwall should be anticipated. See the comments elsewhere in the report regarding the walls and framing.

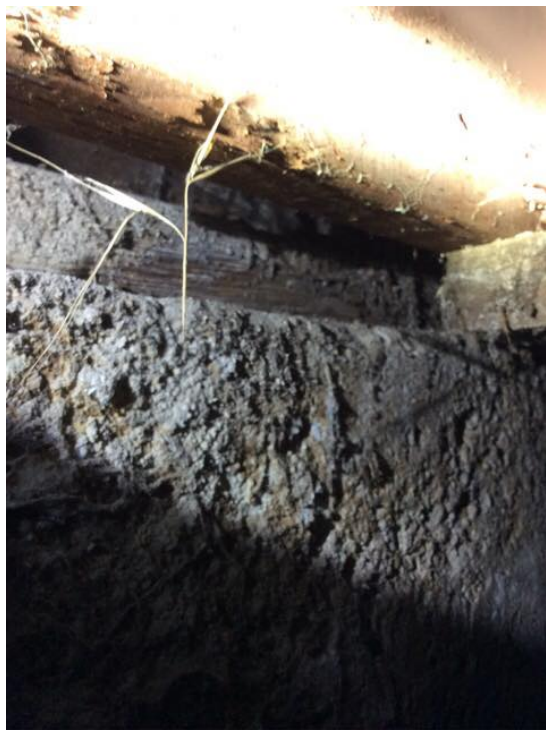
**121:** - The wall framing near at the east side near the access opening is displaced and damaged due to movement of the underlying foundation wall. A previous substandard repair attempt has been made. The repair appears ineffective and has failed. Changes in use or other conditions could lead to additional damage or failure. We recommend the framing be repaired or replaced in accordance with present standards.

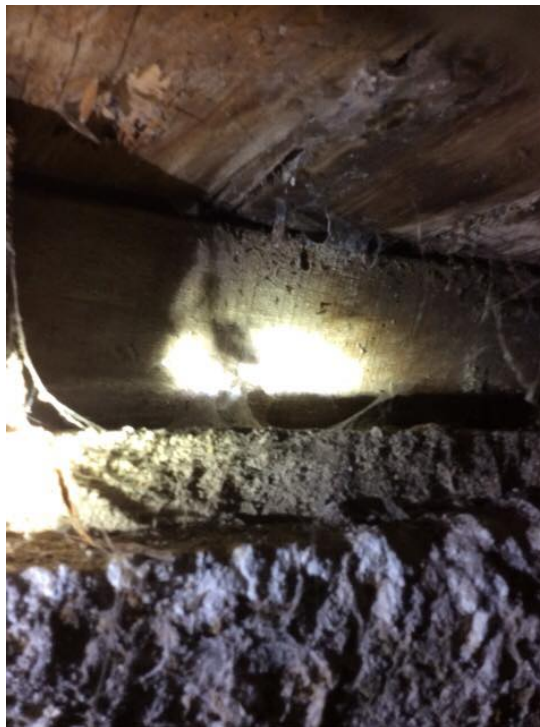
**122:** - Generally, the subflooring is in serviceable condition. However, the subfloor beneath the kitchens and bathrooms plumbing systems is degraded and damaged. Approximately 5 to 7 active leaks are noted at the drain line systems in the crawlspace. We recommend the subflooring be repaired and all damaged material replaced. A termite inspector should be consulted for a further examination, recommendations and repair.

**123:** - We recommend all damaged materials be replaced. Because damage may extend into the inaccessible framing and associated members, the extent of concealed damage will not be known until repairs are in progress.

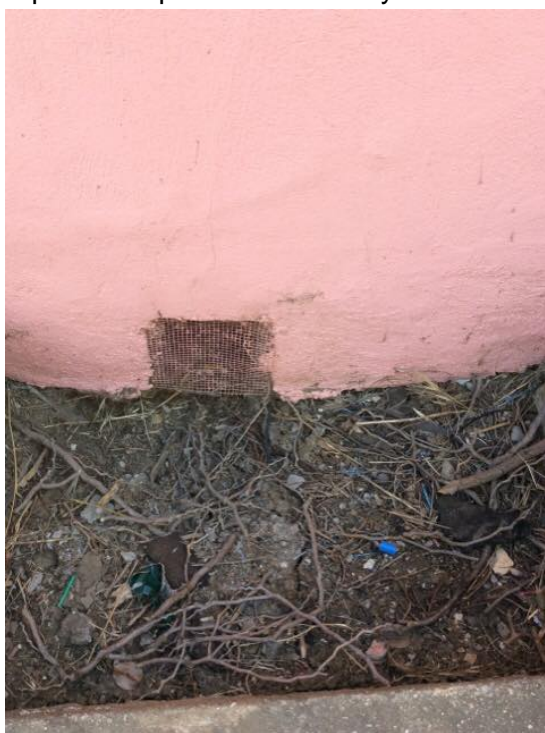
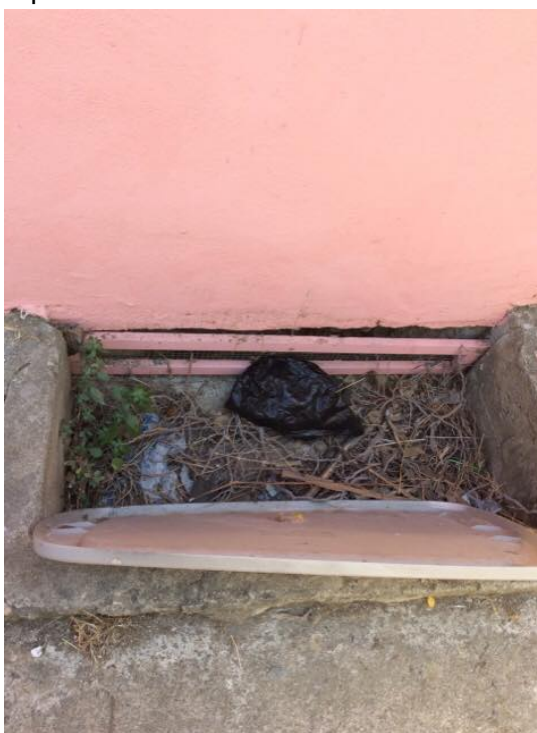
**136:** - Several crawl space vent screens are damaged or incomplete. We recommend they be repaired or replaced to prevent access by rodents or other pests.

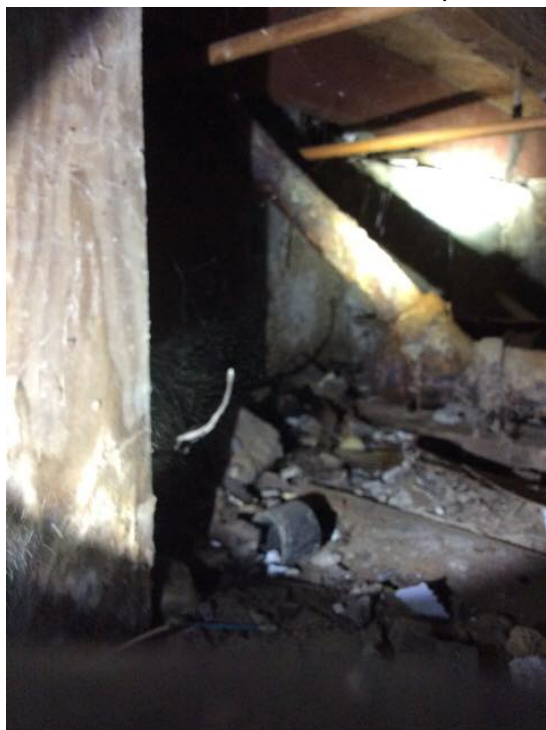
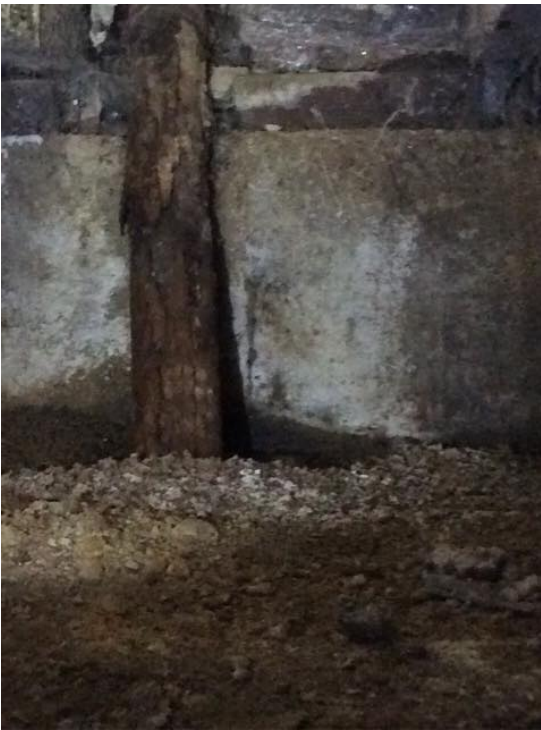
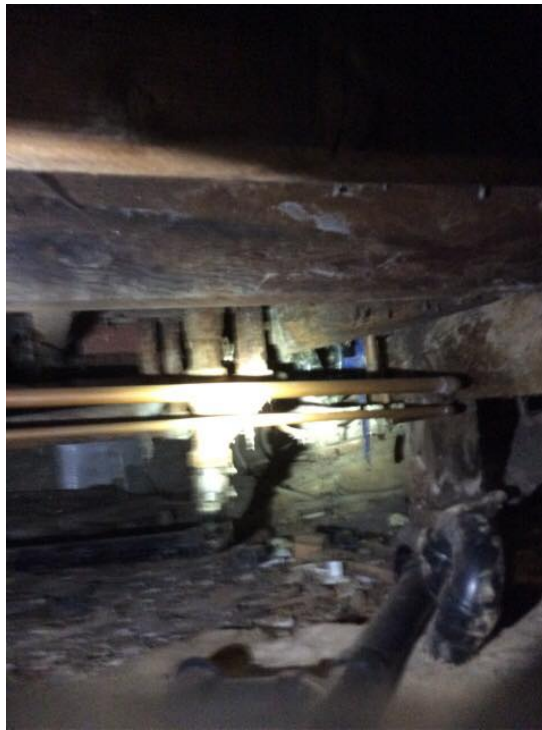
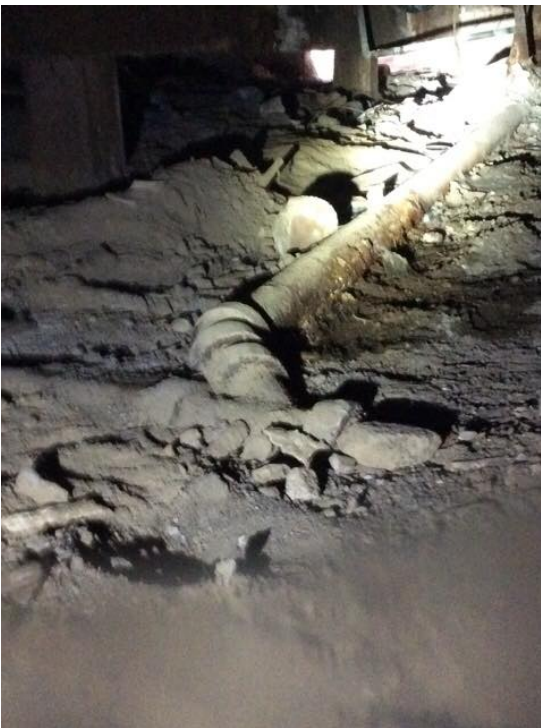
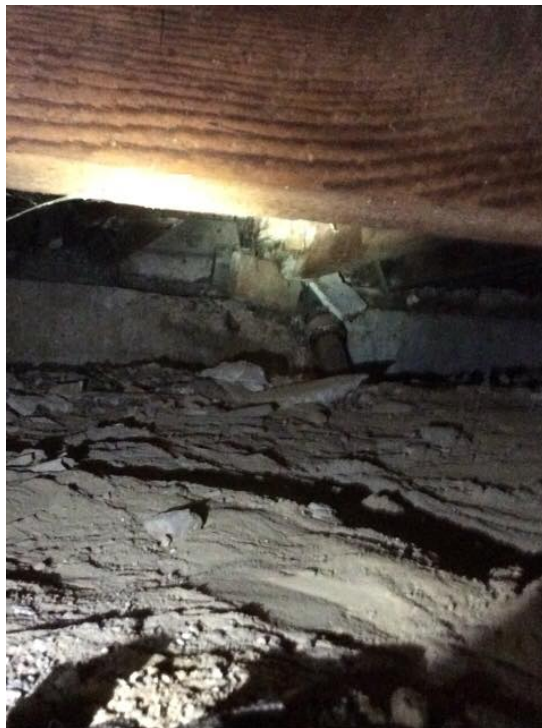
**143:** - There is surface deterioration, cracks and leakage at the exposed and accessible piping. We recommend that these lines be repaired or replaced.

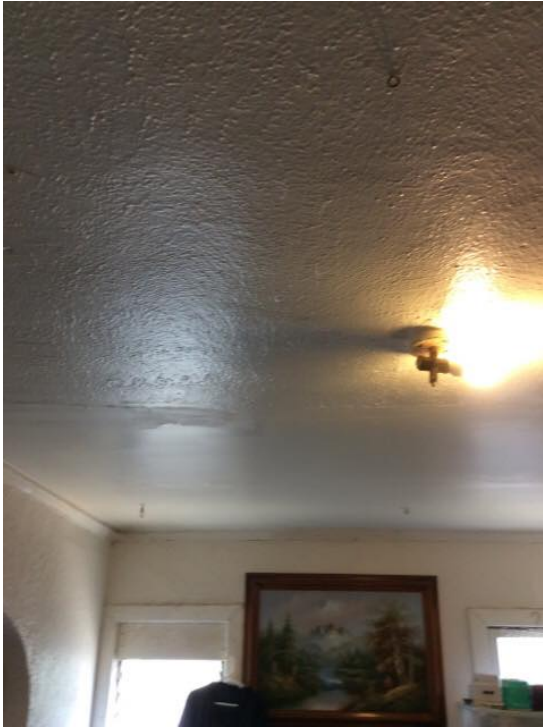
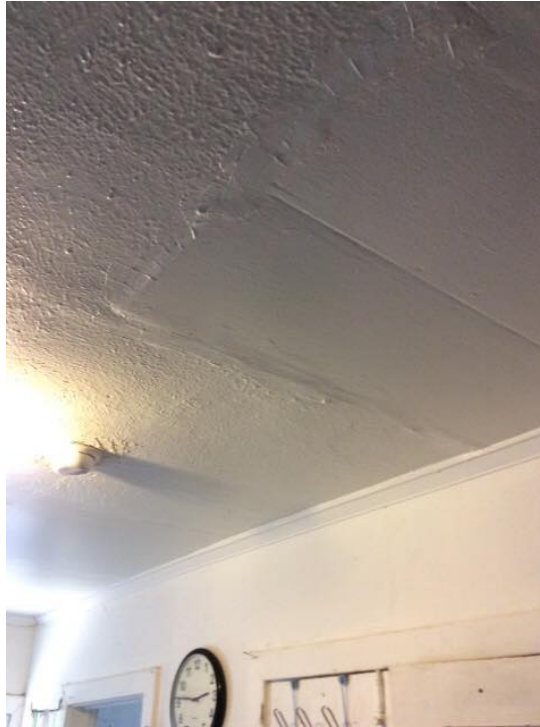
**181:** - Repaired areas are noted at the ceiling. The repairs appear to be the result of past roof leaks. The owner should be consulted regarding the circumstances and repairs.

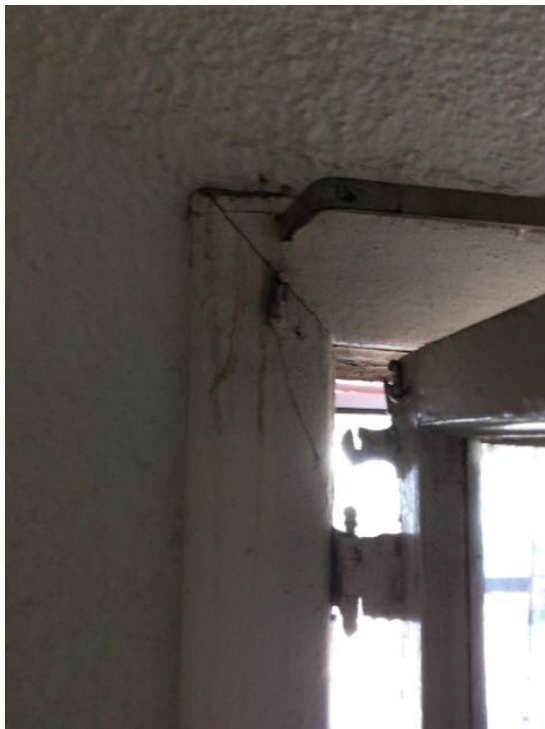
**184:** - There is water staining, however no sign of active leakage was detected. If additional staining develops, the source of leakage should be identified and necessary repairs performed. Prepare and refinish the surface to restore its appearance.
