# Confidential Inspection Report

LOCATED AT:  
3200 Larissa Dr.  
Los Angeles, CA 90026

INSPECTED ON:  
Wednesday, September 5, 2018

Inspector, Joe Bass  
Bass Building Inspection, Inc.

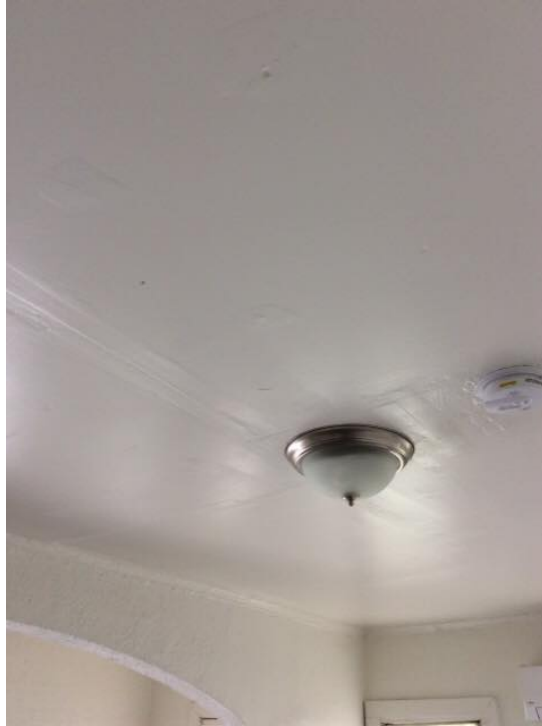
**192:** - The ceiling has been repairs in a substandard manner. We recommend it be repaired or refinished.

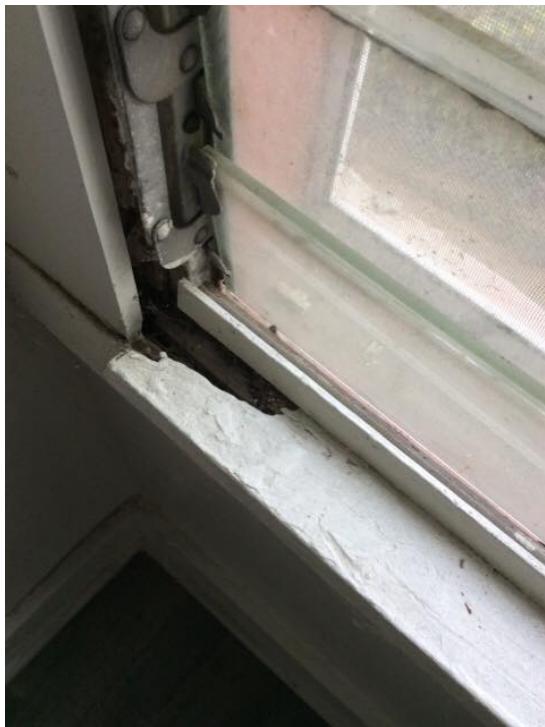
**197:** - One or more windows are deteriorated. We recommend they be repaired or replaced. A termite inspector should be consulted for a further examination, recommendations and repair.

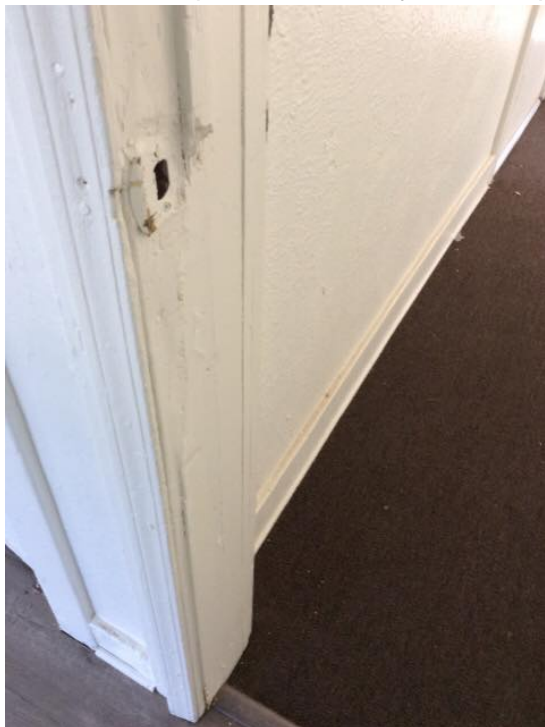
**199:** - The stop rail at the entry is in complete. Doors are missing at the closet.

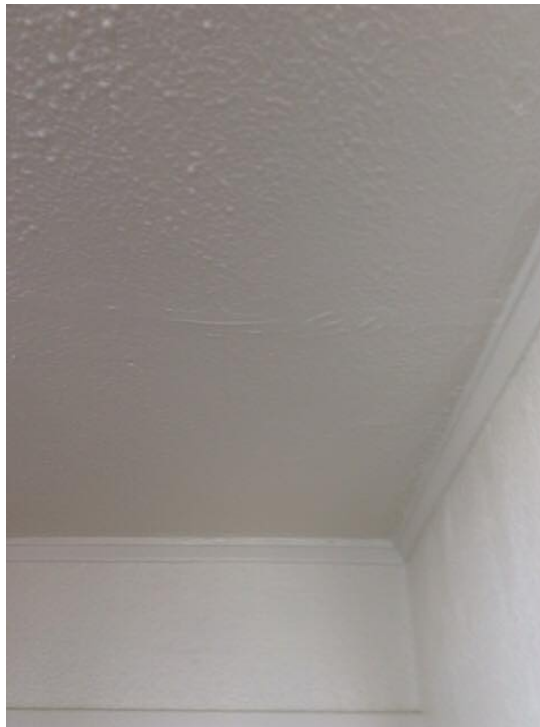
212: - Repaired areas are noted at the ceiling. The repairs appear to be the result of past roof leaks. The owner should be consulted regarding the circumstances and repairs.

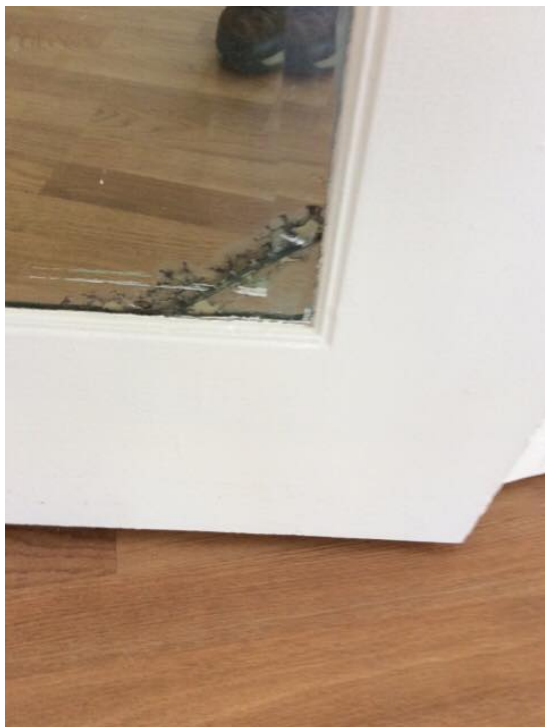
**218:** - The mirror at one closet door is cracked.

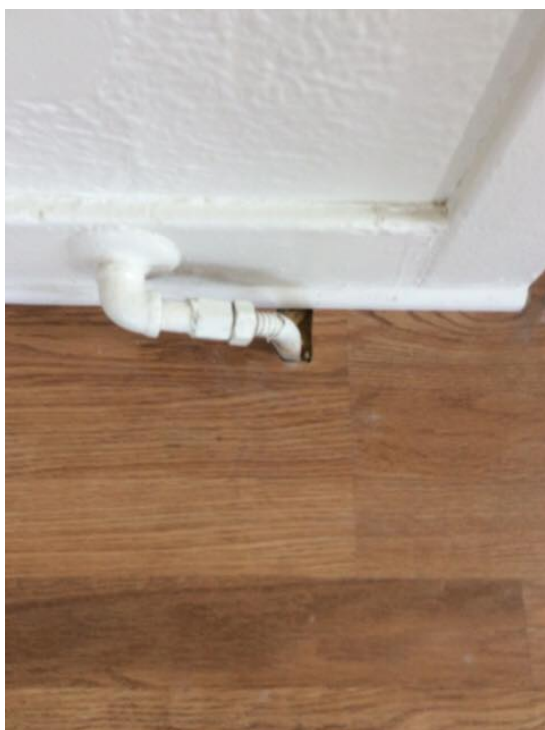
**220:** - The flexible gas line entering the floor is substandard. We recommend it be repaired in accordance to standards.

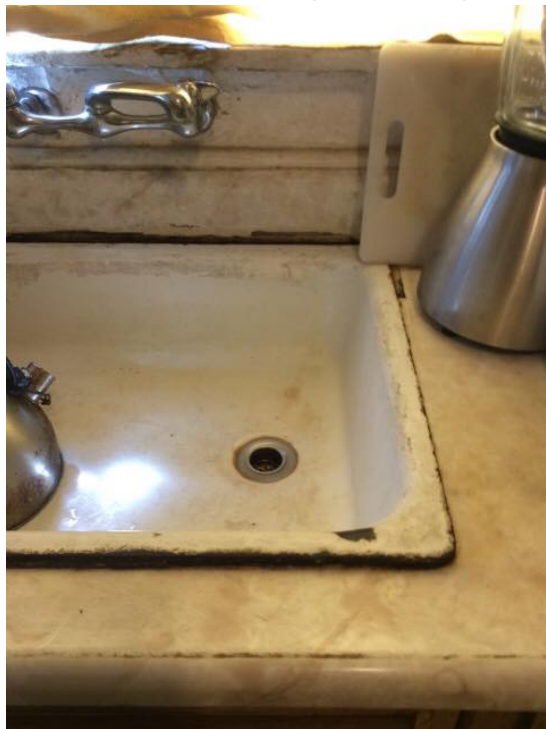
**224:** - The countertop is deteriorated, which affects its appearance and may limit its remaining useful life. We recommend it be repaired or replaced.

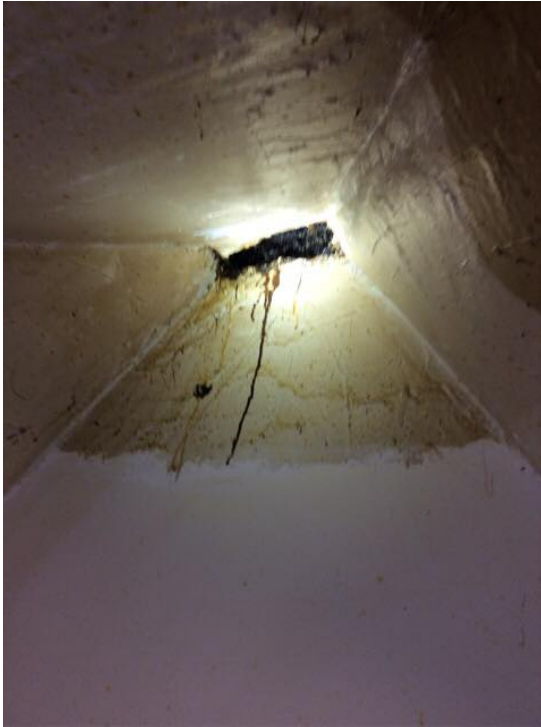
**236:** - The kitchen is equipped with a ceiling vent opening. The vent is heavily grease-laden. This is a significant fire hazard. We recommend this be corrected this time by thoroughly cleaning or replacement.

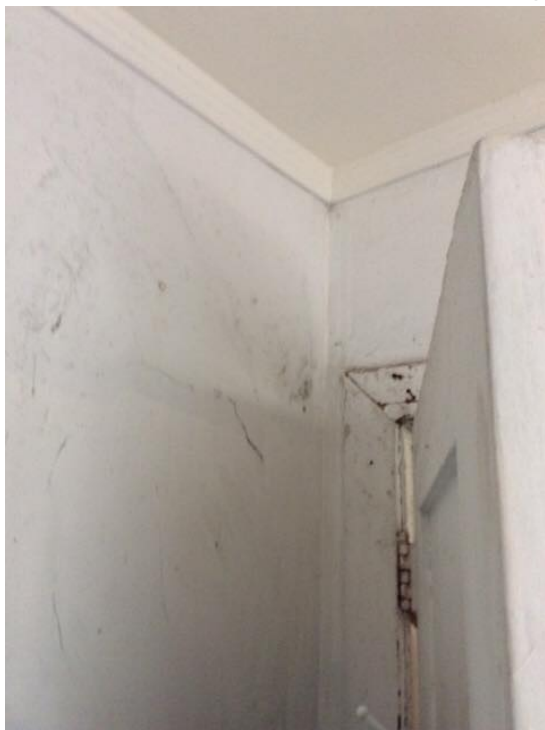
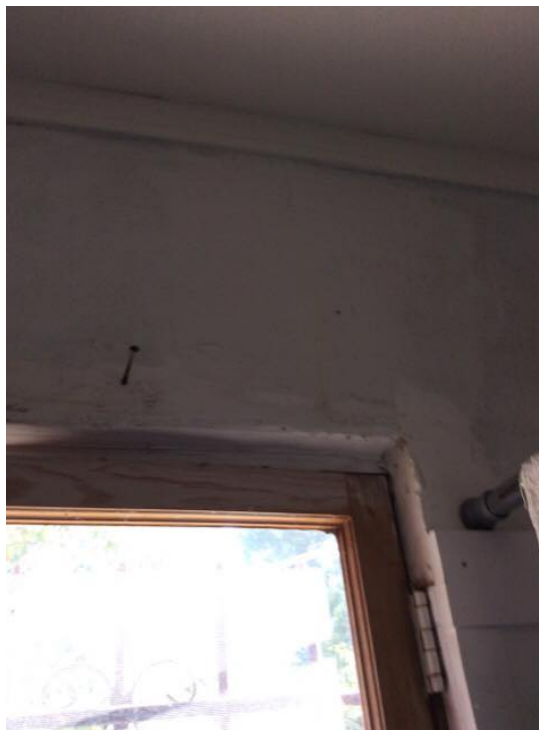
**284:** - There are blemishes and finish repairs needed.

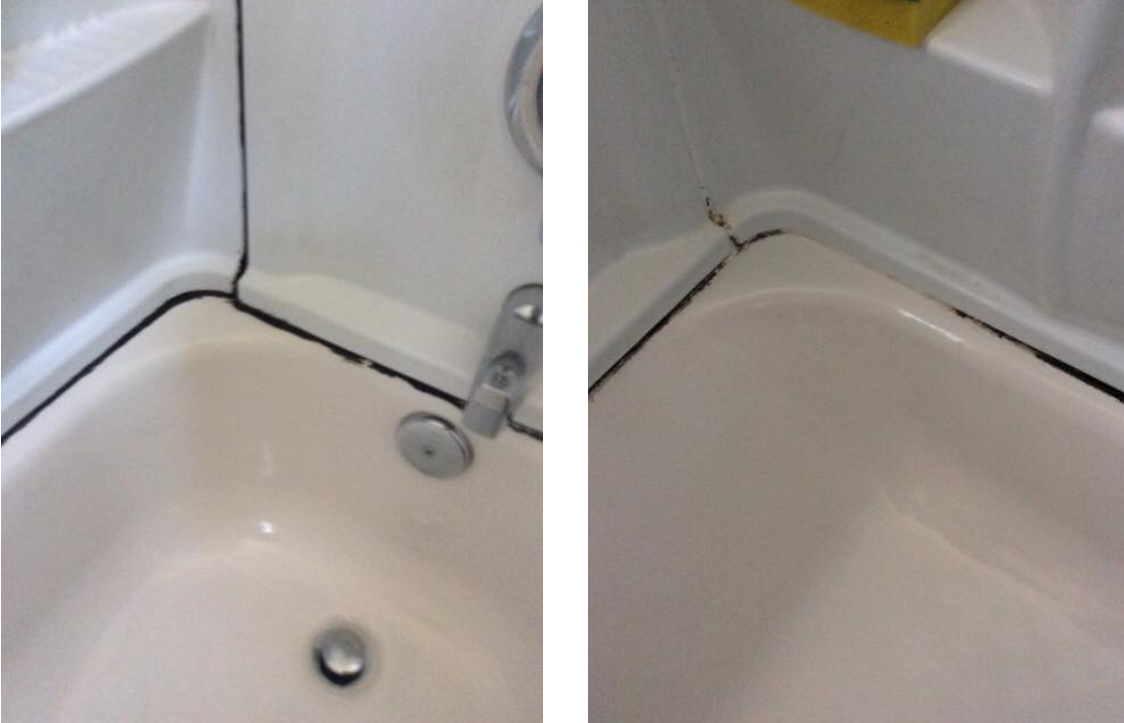
**290:** - Caulking and/or grout repairs are needed at the bathtub rim.

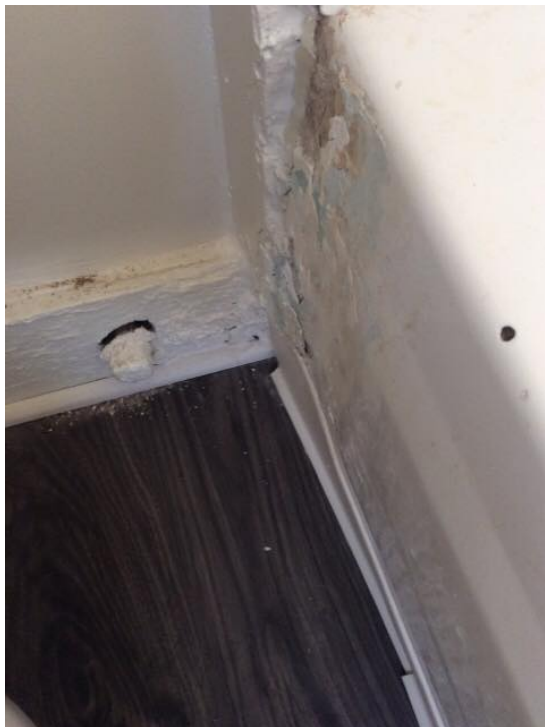
**325:** - Water damages observed at the east wall in bathtub. This appears to be a result of water from leaking from the bathtub and shower area.
