# Confidential Inspection Report

LOCATED AT:  
3200 Larissa Dr.  
Los Angeles, CA 90026

INSPECTED ON:  
Wednesday, September 5, 2018

Inspector, Joe Bass  
Bass Building Inspection, Inc.

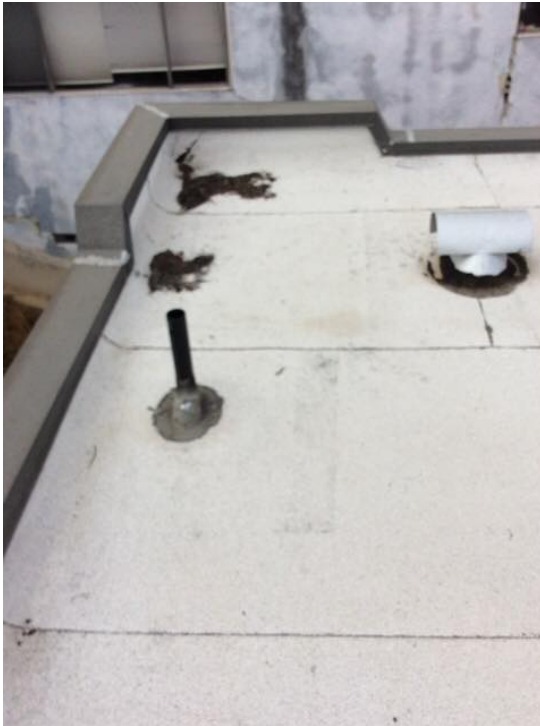
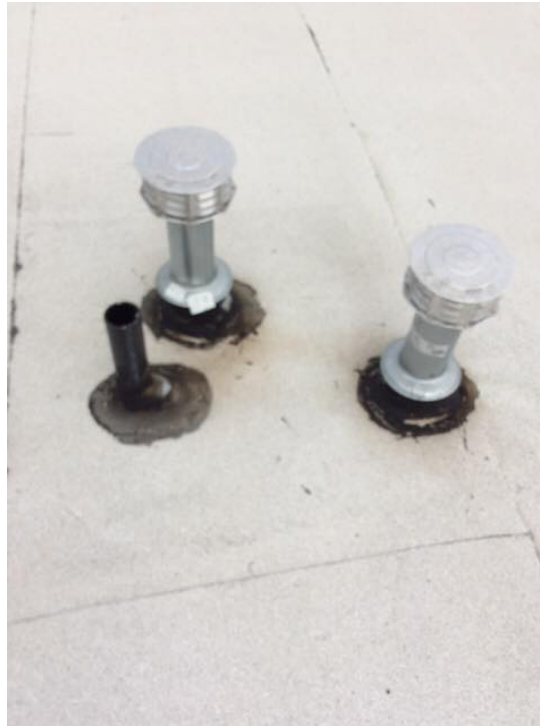
**36:** - There are plastic plumbing vents protruding through the roof. Standards require this type of pipe be protected and, in most jurisdictions, this has been interpreted to mean painted for protection against the sun. We recommend the vents be painted for maximum durability.

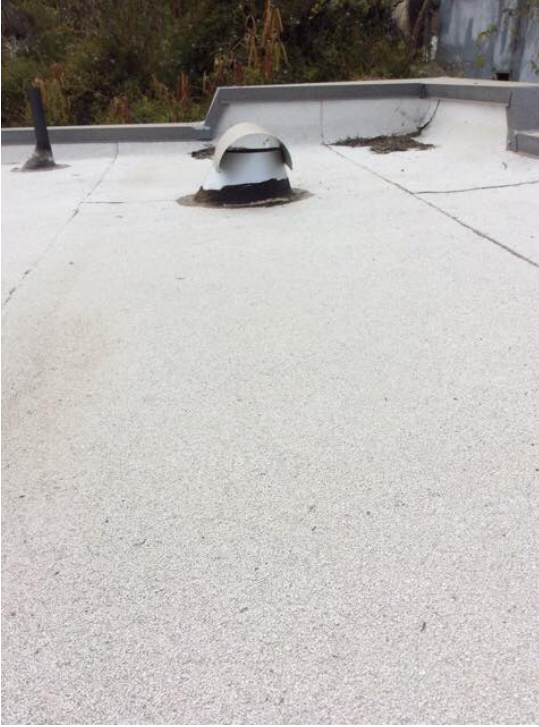
**37:** - Installation of 1/4 inch mesh screens at the applicable vent openings is recommended to prevent intrusion of animals and pest into the home.

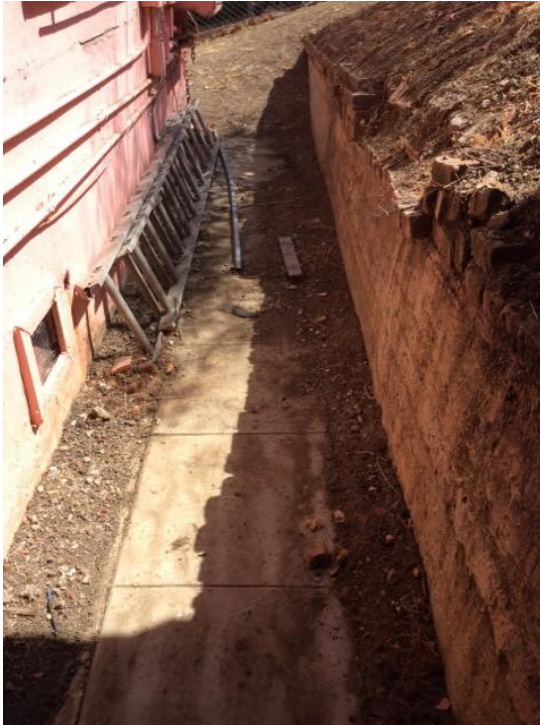
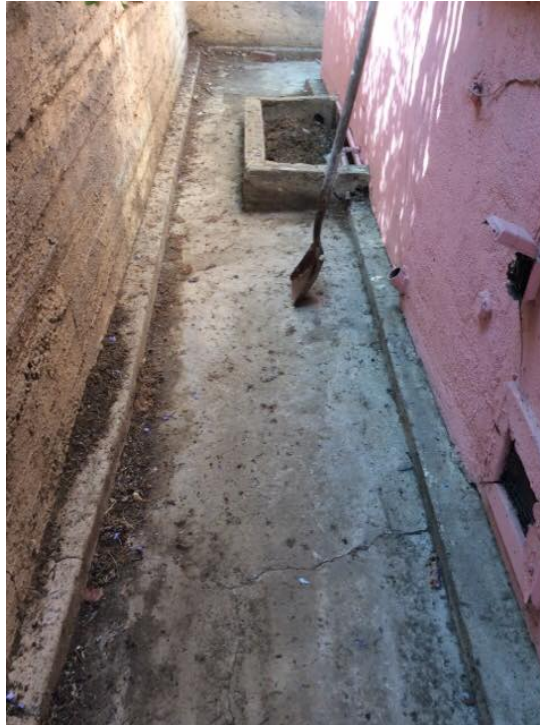
**70:** - Evidence of water pooling at the grounds is observed. Improvement to the site drainage is recommended. See the comments elsewhere in the report for remarks regarding drainage.

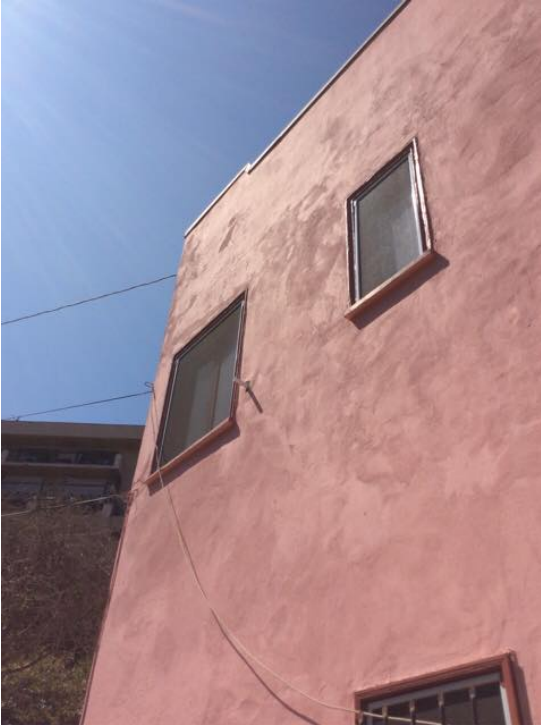
**75:** - Portions of the exterior appear recently painted. Numerous cracks and repaired areas are noted at the stucco throughout the building. As with any recently refinished and freshly painted surface, the stucco may have conditions present that were not readily apparent at the time of our inspection. We do not suggest that this inspection has identified all such conditions.

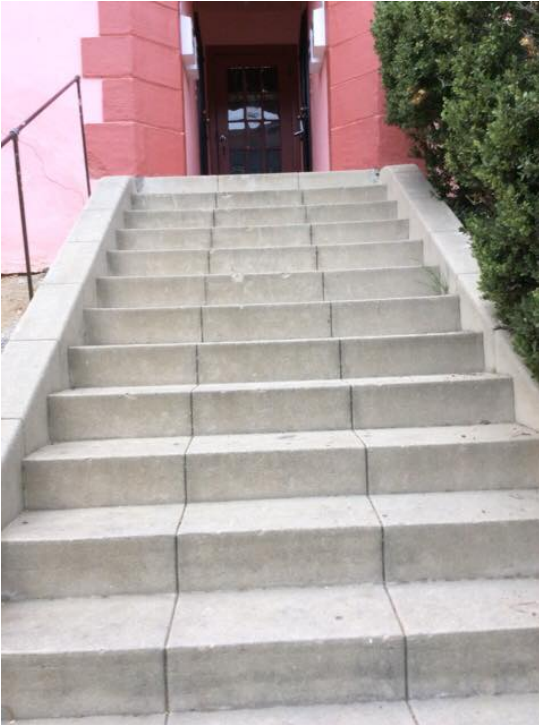
96: - The exterior stairs appear to be properly constructed and are in serviceable condition.

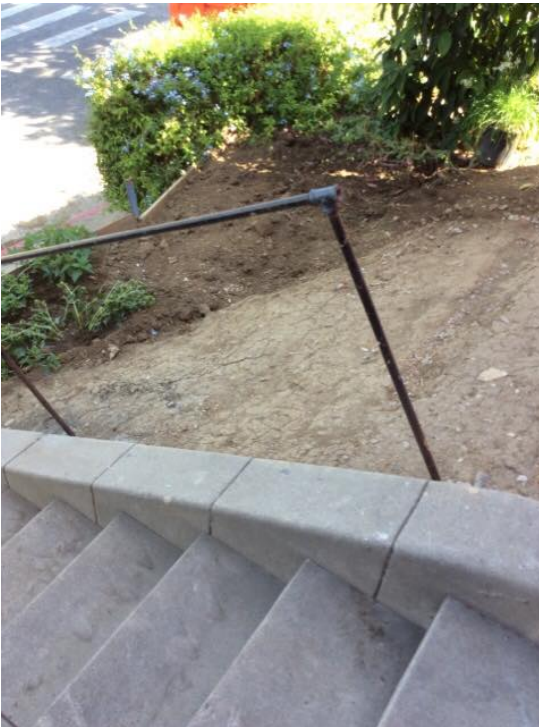
97: - The dimensions of the hand and guardrails at the stairways and balconies do not comply with current standards. The conditions may be permissible under the "Grandfather Clause". However installation of conforming hand and guard rail systems should be considered.

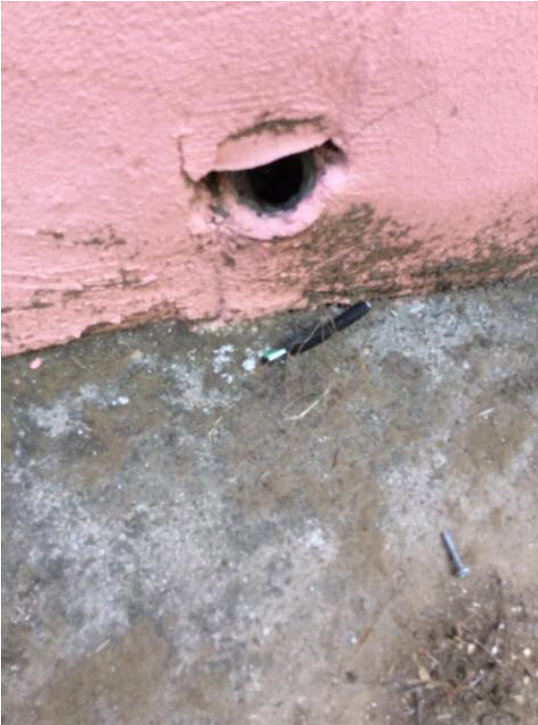
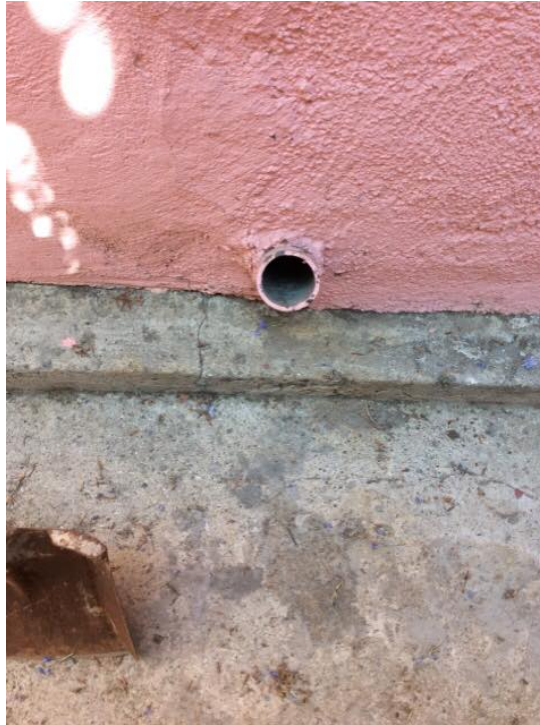
**101:** - Clean-out caps at the exterior walls are missing. We recommend they be replaced.

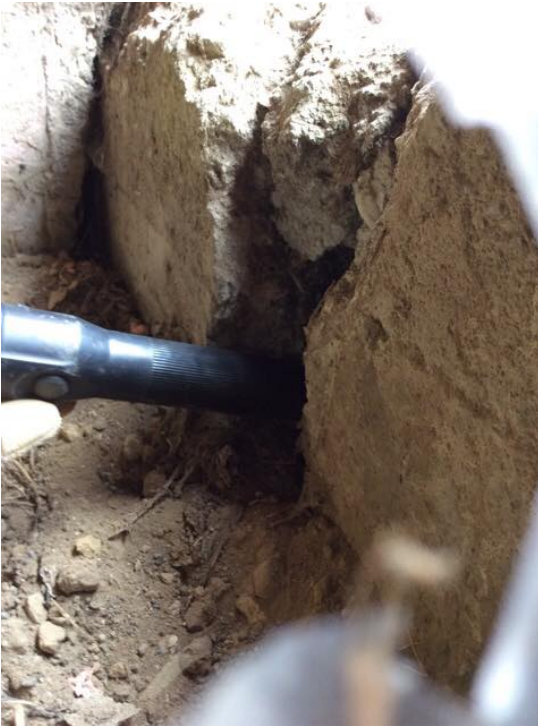
**113:** - Approximately 4-6 expansive cracks and significant displacement is observed at the concrete stem walls. The source/significance is not determined. The need for significant repairs or replacement of the damaged portions of the foundation stemwall should be anticipated. See the comments elsewhere in the report regarding the walls and framing.

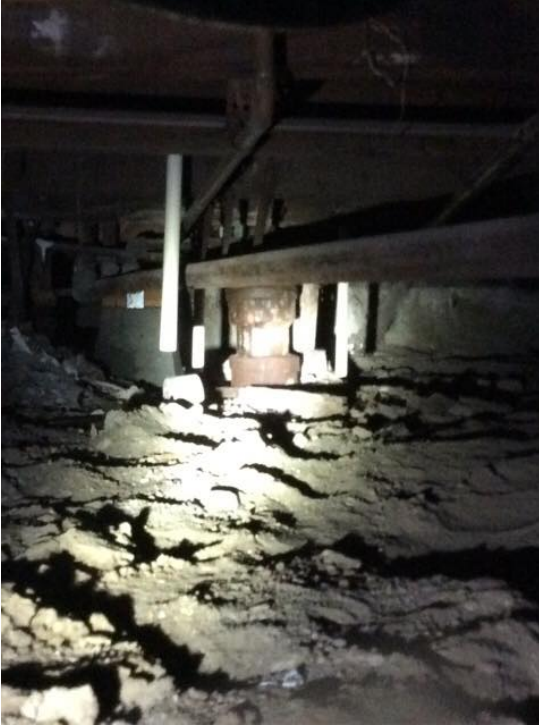
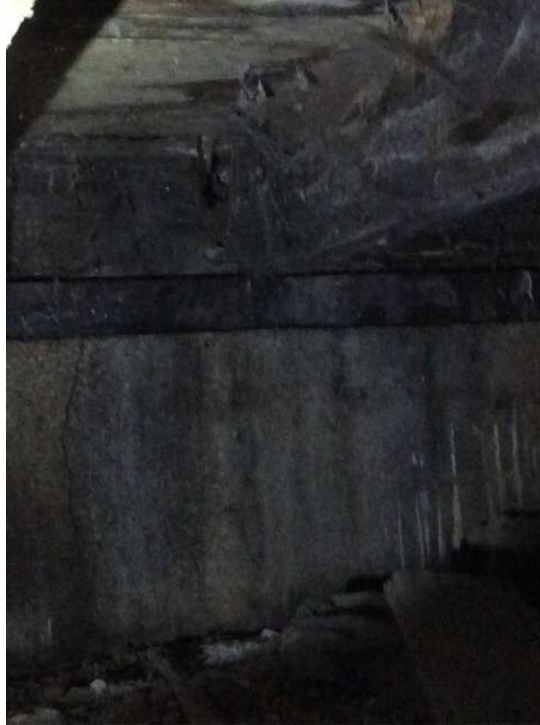
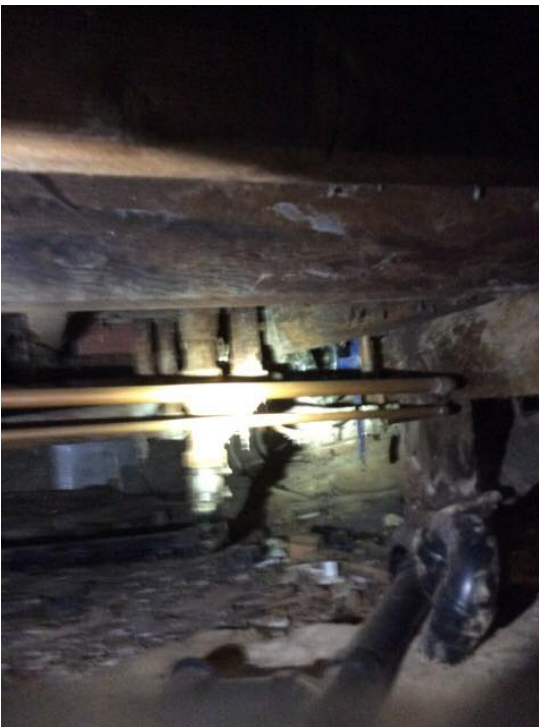
**122:** - Generally, the subflooring is in serviceable condition. However, the subfloor beneath the kitchens and bathrooms plumbing systems is degraded and damaged. Approximately 5 to 7 active leaks are noted at the drain line systems in the crawlspace. We recommend the subflooring be repaired and all damaged material replaced. A termite inspector should be consulted for a further examination, recommendations and repair.

**123:** - We recommend all damaged materials be replaced. Because damage may extend into the inaccessible framing and associated members, the extent of concealed damage will not be known until repairs are in progress.

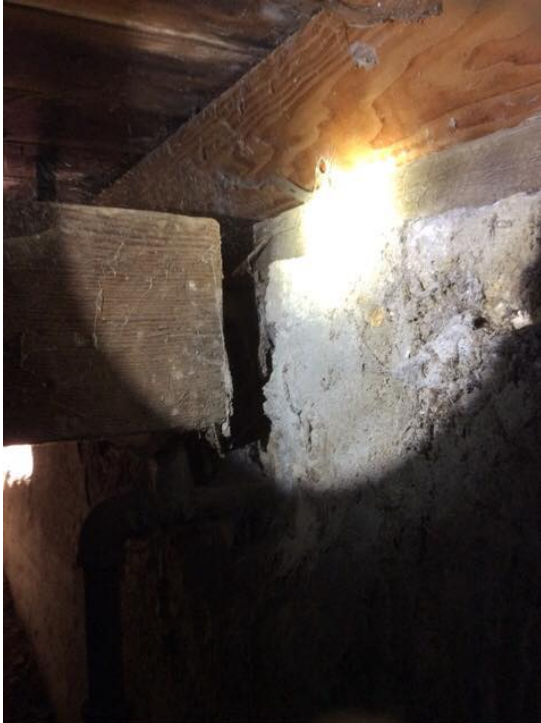
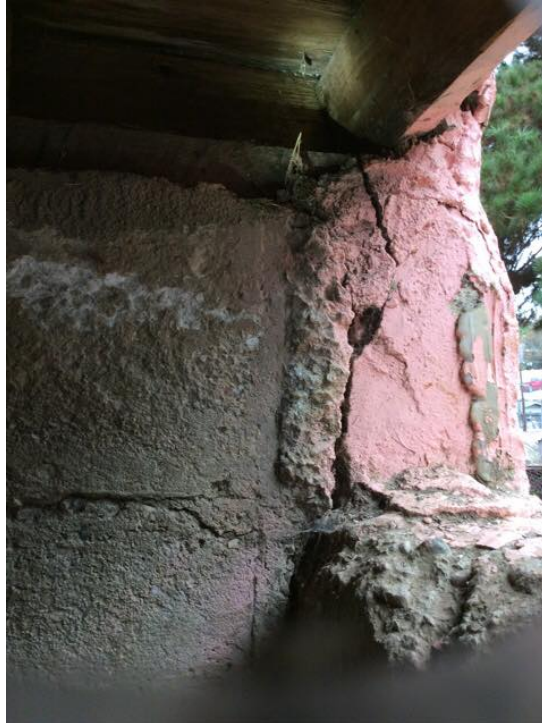
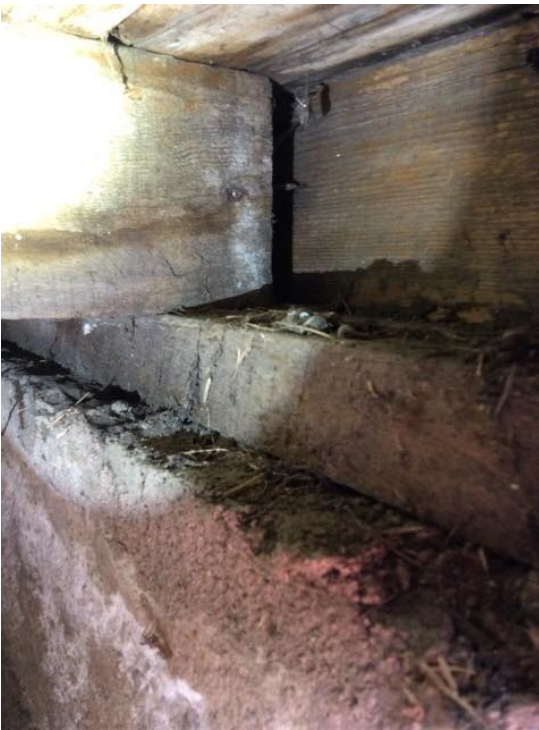
**125:** - Several beams at the east region no longer bearing due to displacement of the foundation wall to the point that they are no longer load bearing. We recommend repair or replacement in accordance with present standards.

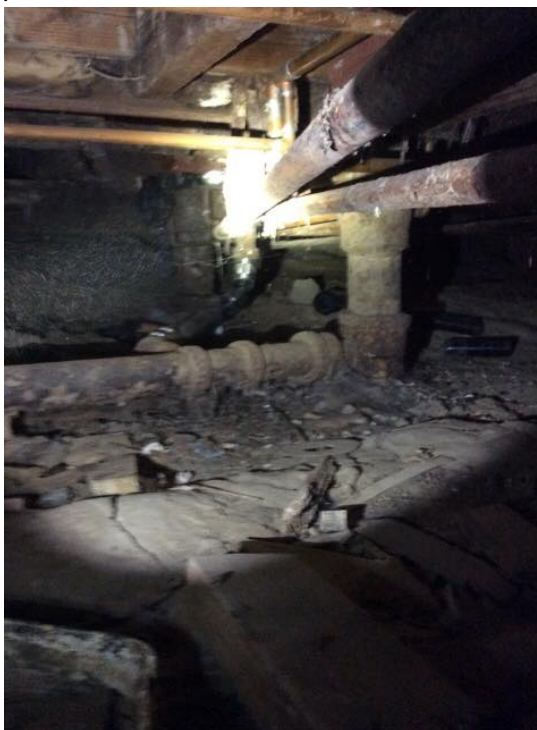
**143:** - There is surface deterioration, cracks and leakage at the exposed and accessible piping. We recommend that these lines be repaired or replaced.

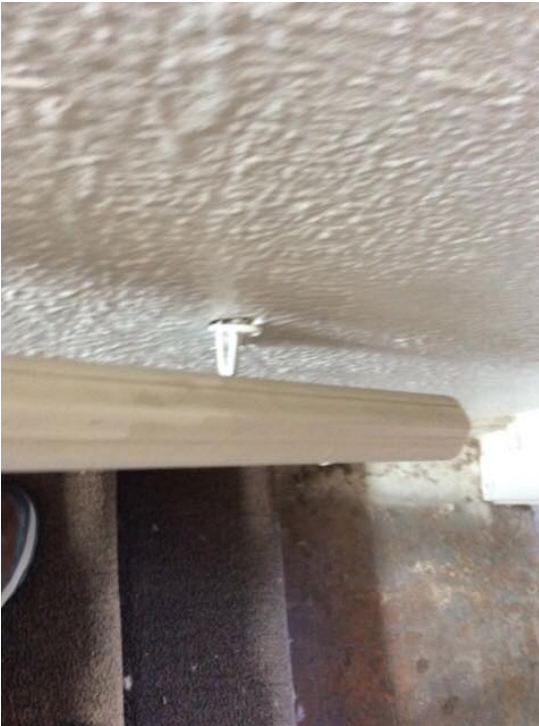
**175:** - The railings at the entry are loose. We recommend they be repaired or replaced.

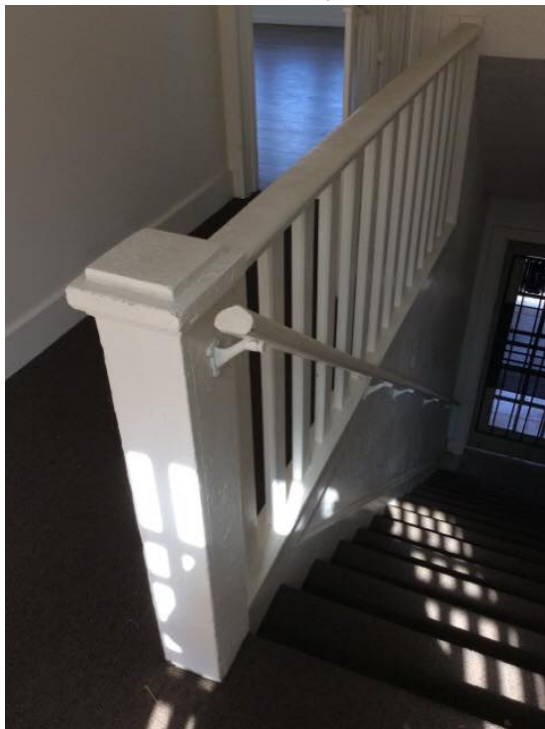
**176:** - The railings are serviceable. However the dimensions of the guard rails and open ends at the hand rails do not comply with current standards. Installation of conforming hand and guardrail systems should be considered as a safety measure.

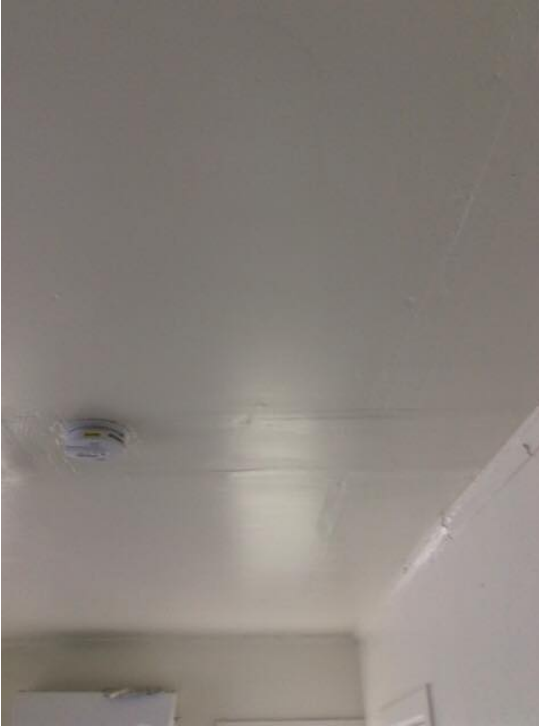
**191:** - Repaired areas are noted at the ceiling. The repairs appear to be the result of past roof leaks. The owner should be consulted regarding the circumstances and repairs.

**192:** - The ceiling has been repairs in a substandard manner. We recommend it be repaired or refinished.

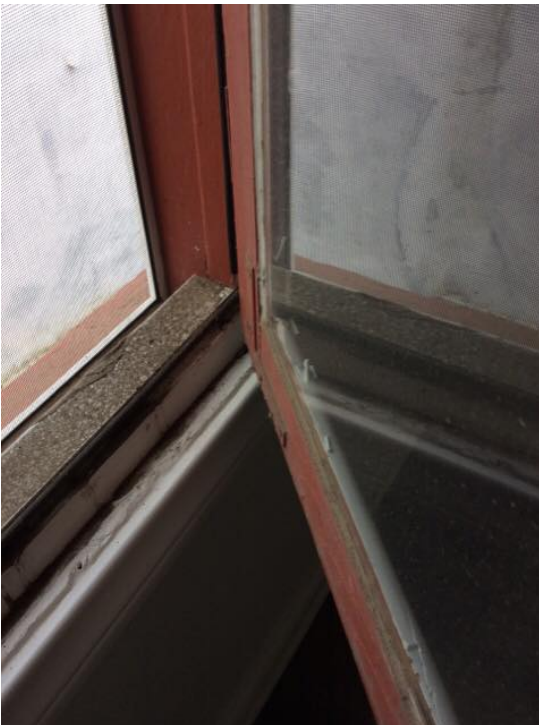
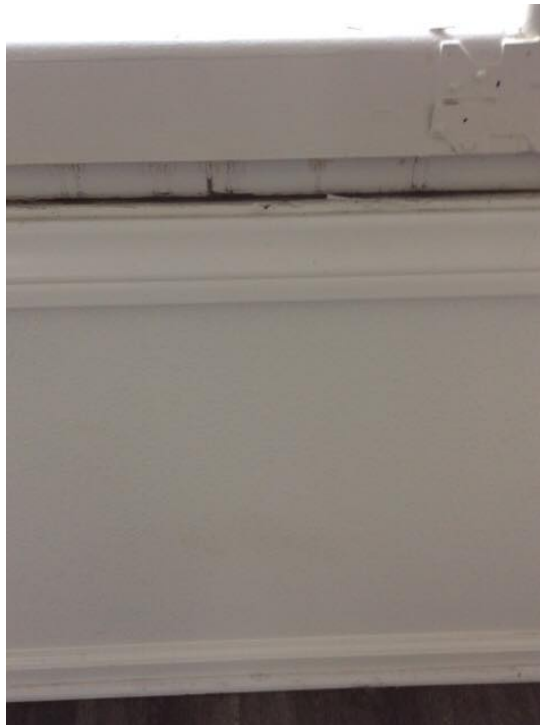
**207:** - The northwest window is not equipped with drip flashings and leaks. We recommend it be repaired or replaced.

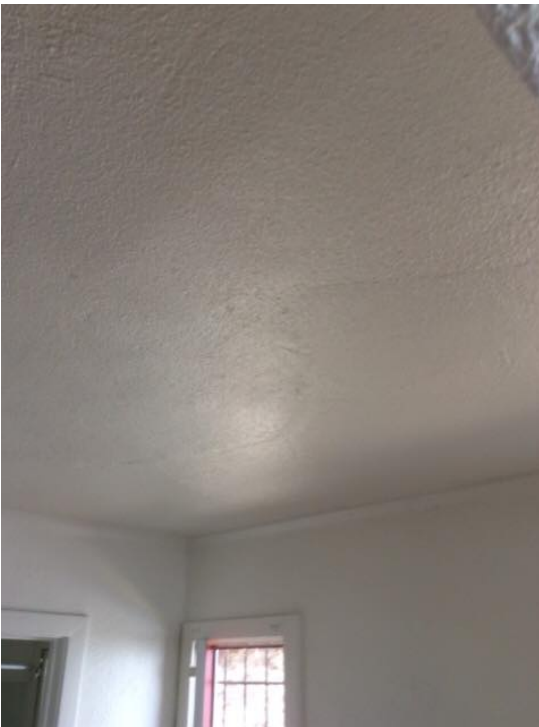
212: - Repaired areas are noted at the ceiling. The repairs appear to be the result of past roof leaks. The owner should be consulted regarding the circumstances and repairs.

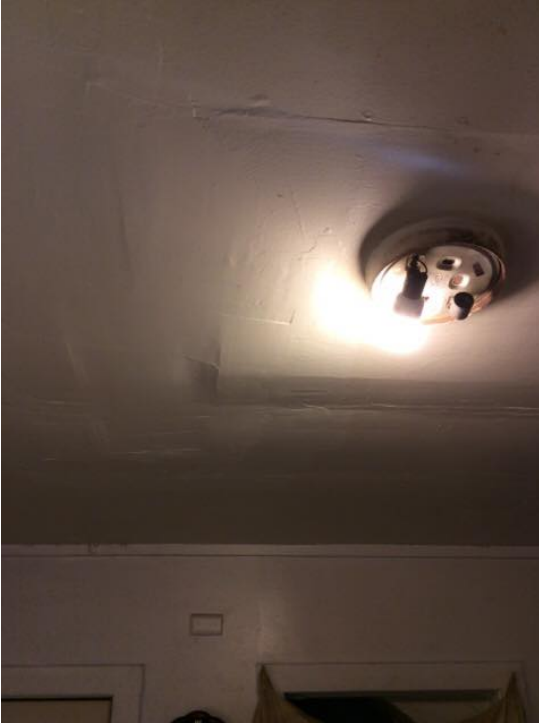
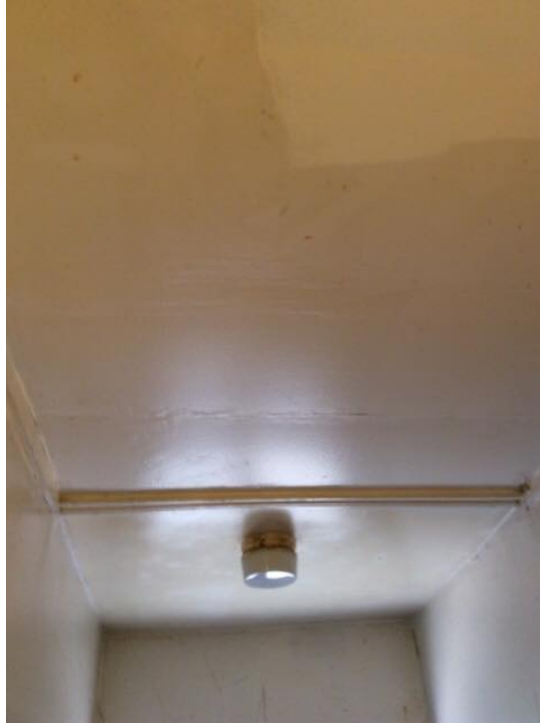
**221:** - Repaired areas are noted at the ceiling. Consult the owner regarding the circumstances.

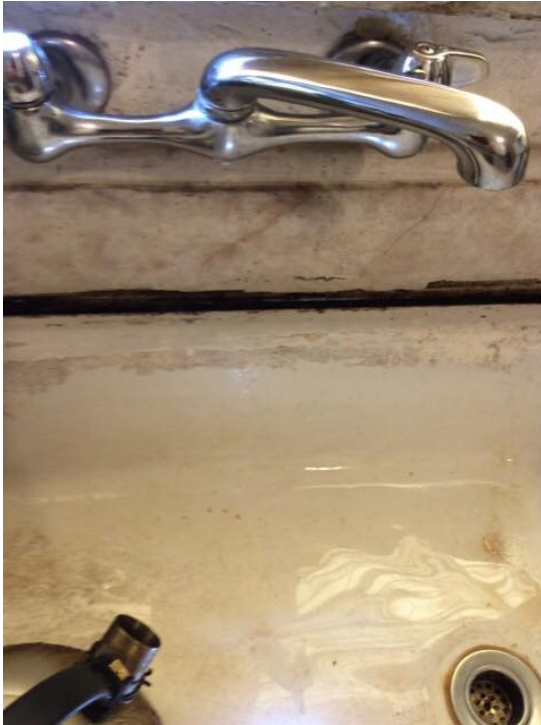
**231:** - The caulking at the sink rim is worn and discolored. Replacement is recommended.

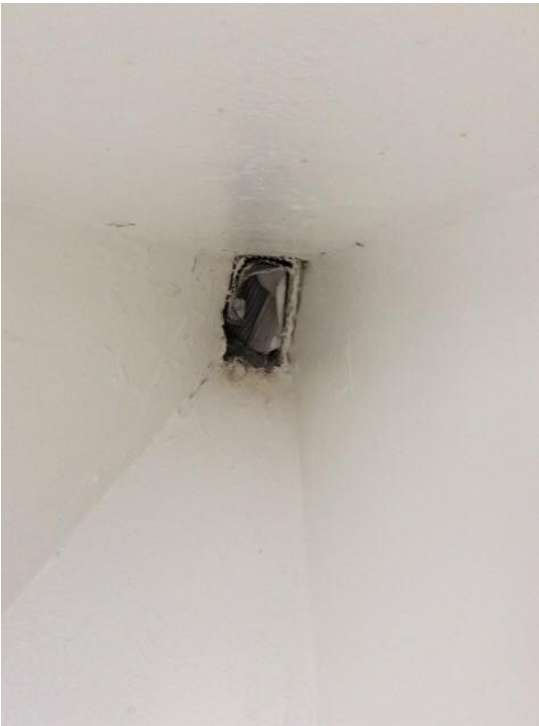
**251:** - Kitchen ventilation is provided by a ceiling opening, venting to the exterior. The vent needs repair as it is obstructed.

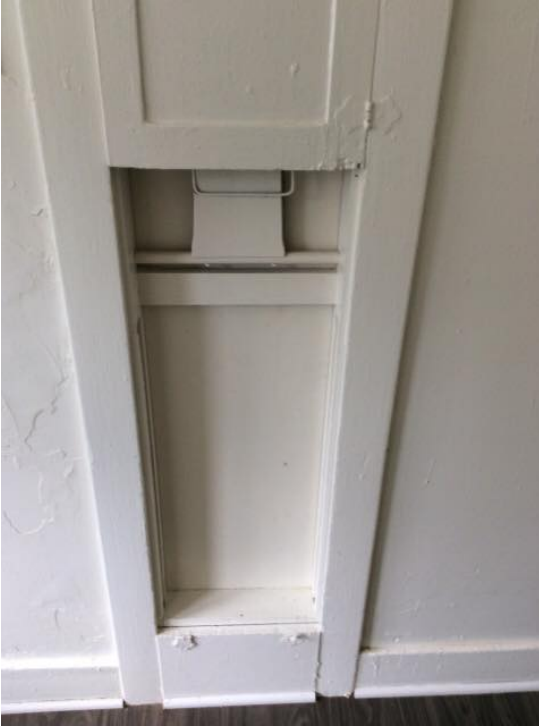
**253:** - The ironing board is incomplete.

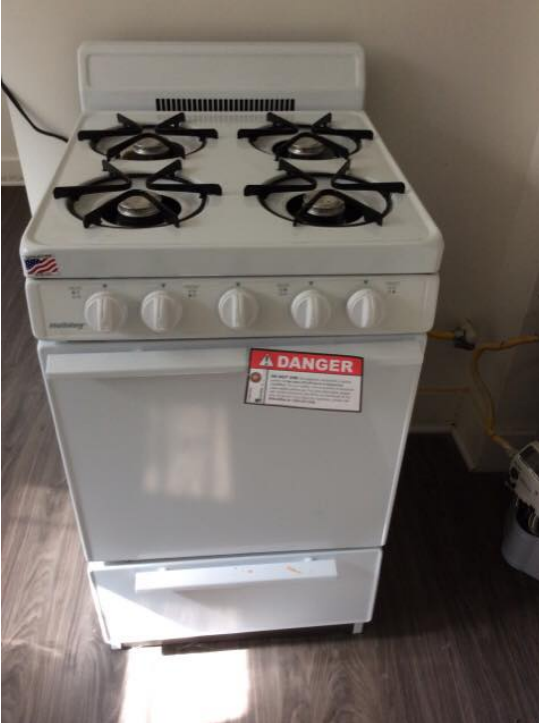
**279:** - The oven and range was examined and operated at the controls and appears in serviceable condition at this time. However it has been "Red Tagged" by the gas company. No obvious deficiencies were observed at the time of the inspection. Consult the owner and gas company regarding circumstances and have repairs have been made.

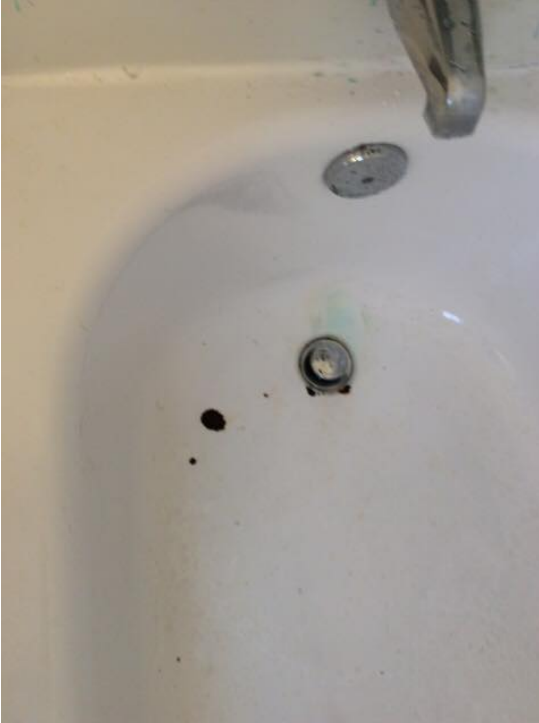
**334:** - The bathtub is worn, suggesting its useful life is limited.

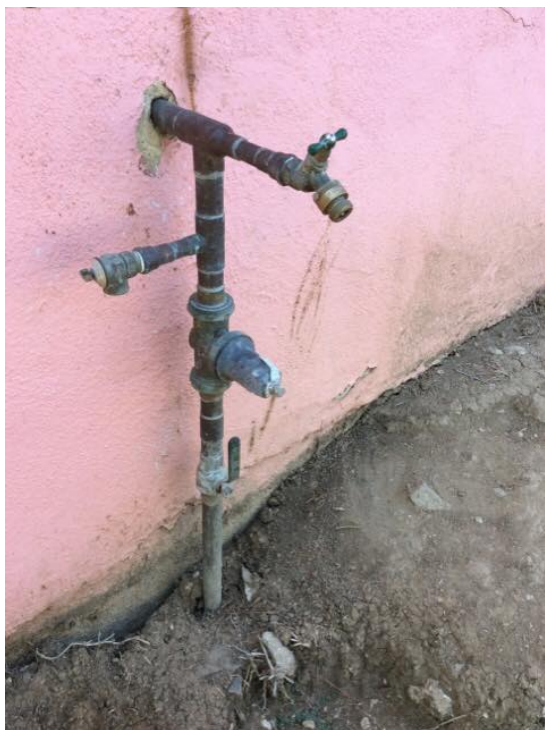
- 344:** - The main water shut off is located at the North grounds.

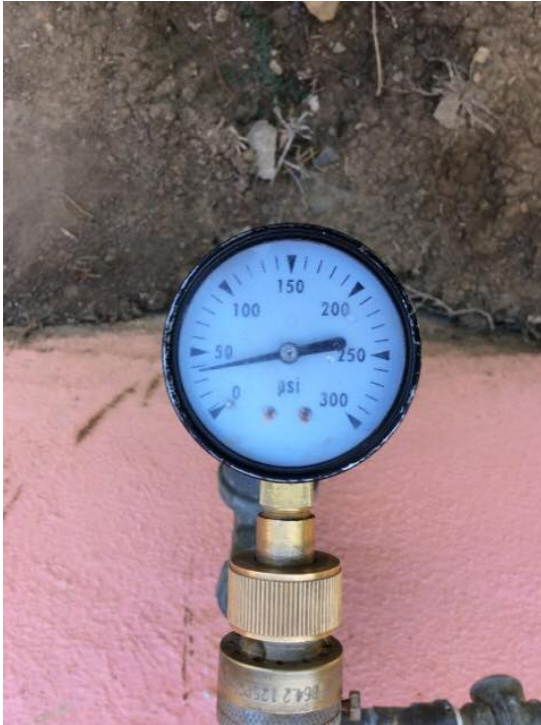
**349:** - The water pressure is tested at 40 P.S.I. (80 P.S.I. or less is standard).

**350:** - The system water pressure, as measured at the exterior water heater and/or hose bibs, is low. We recommend that the pressure regulator valve be serviced and adjusted.

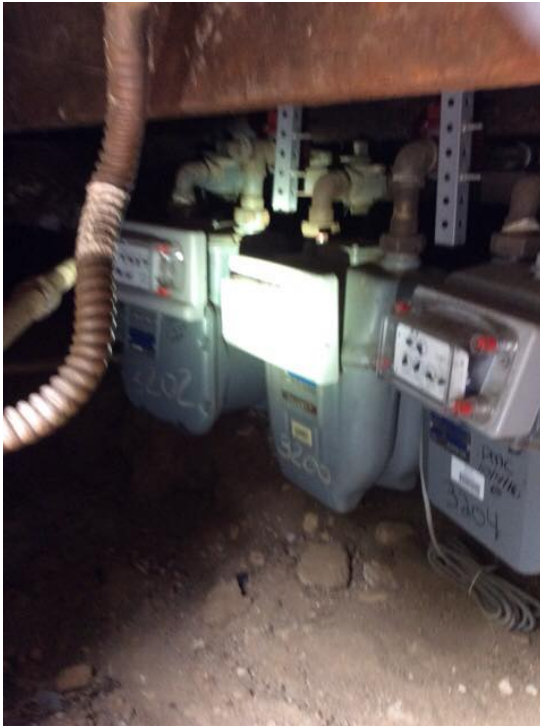
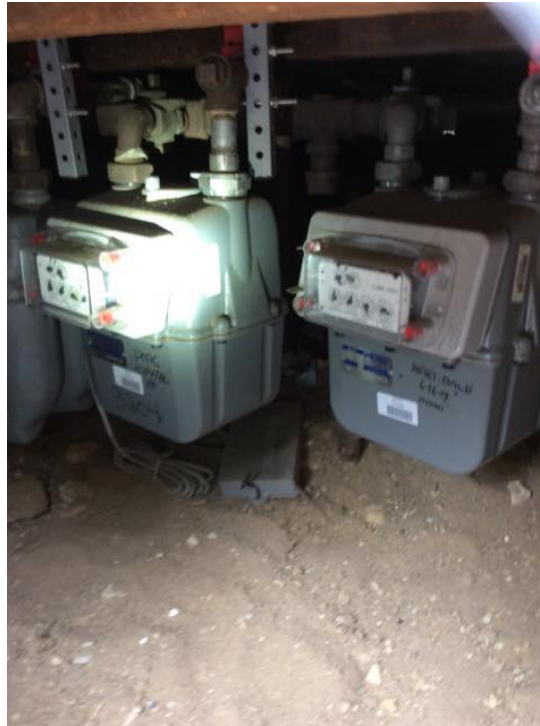
**355:** - The gas meter is in the crawl space. The location does not comply with current standards and is no longer a standard practice. However the condition may be permissible under the "Grandfather Clause". The main gas supply shutoff valve is located on the riser pipe between the ground and the meter. This valve should be turned 90 degrees (either way) in order to shut off the gas.

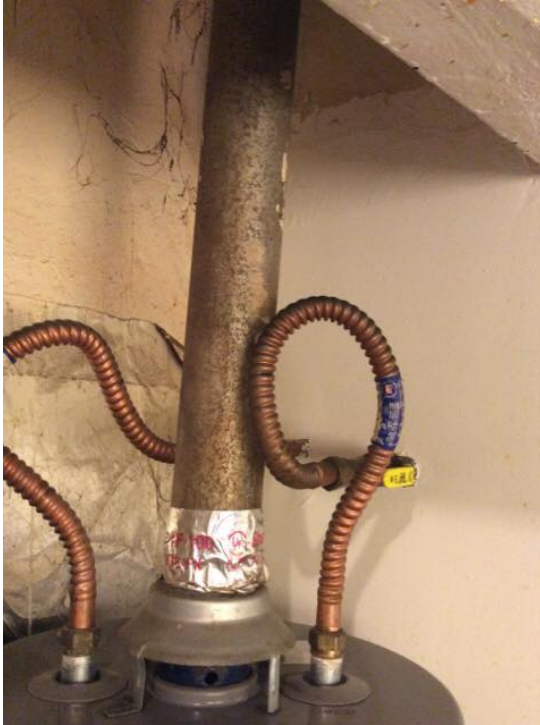
**374:** - The single wall vent materials are non-conforming. The condition may be permissible under the "Grandfather Clause". We recommend it be replaced during the time of replacement of the water heater to comply with current standards.

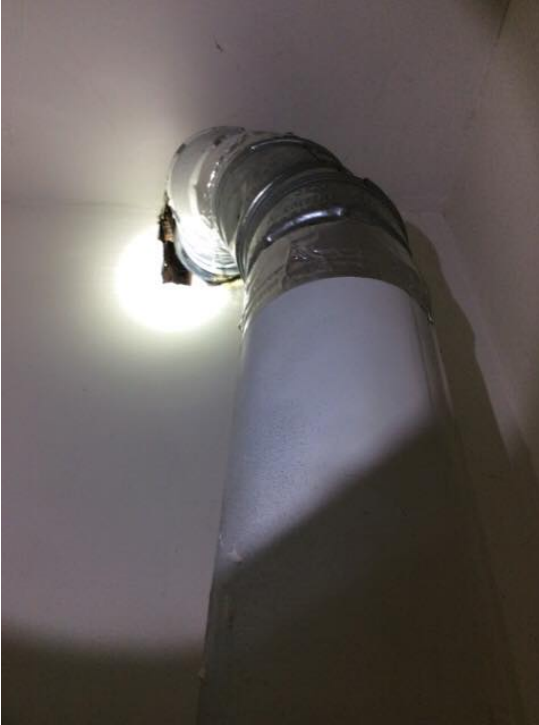
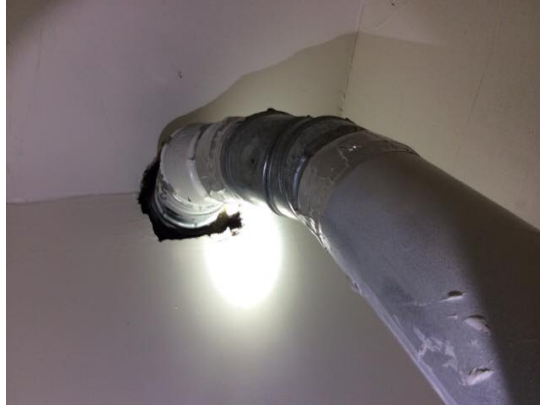
**420:** - The water heater vent is installed too close to a combustibile surface. We recommend that approved clearance be provided. 1 inch clearance is standard.

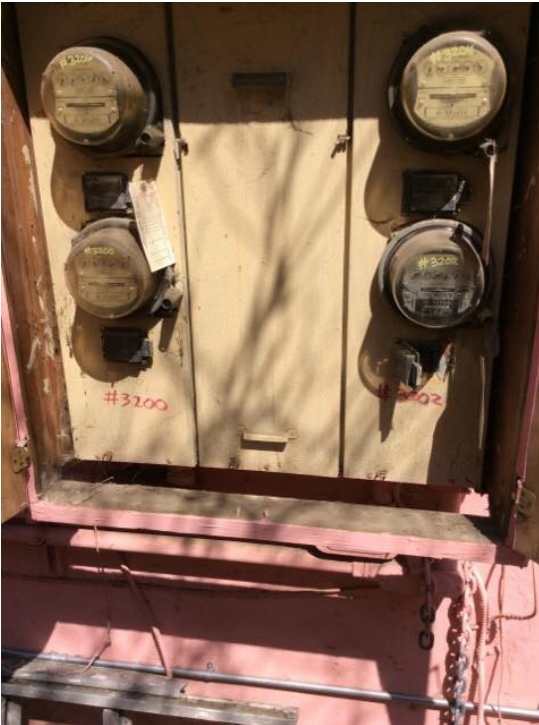
- 432:** - The meter and main electrical service panel are located at the South wall.

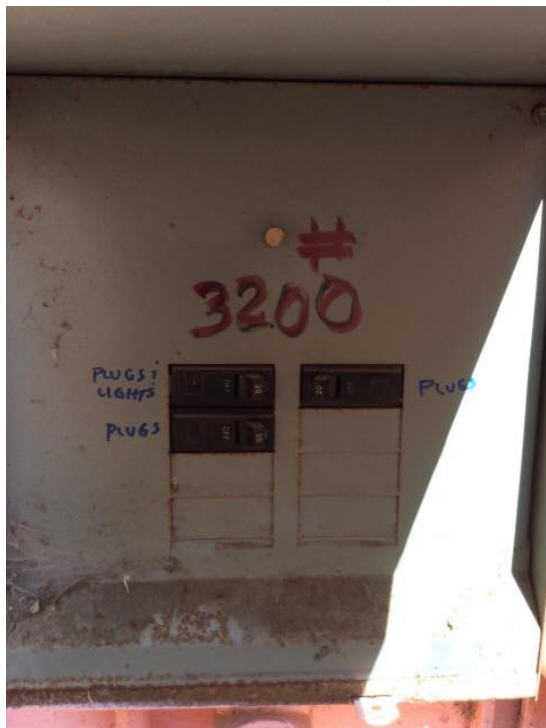
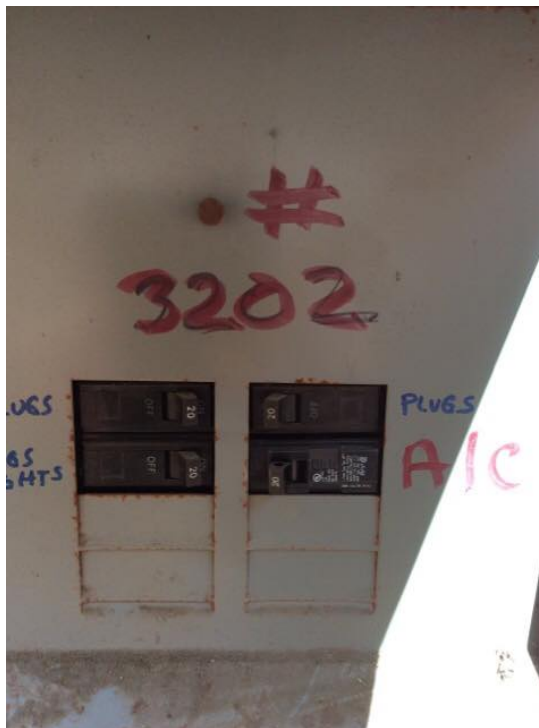
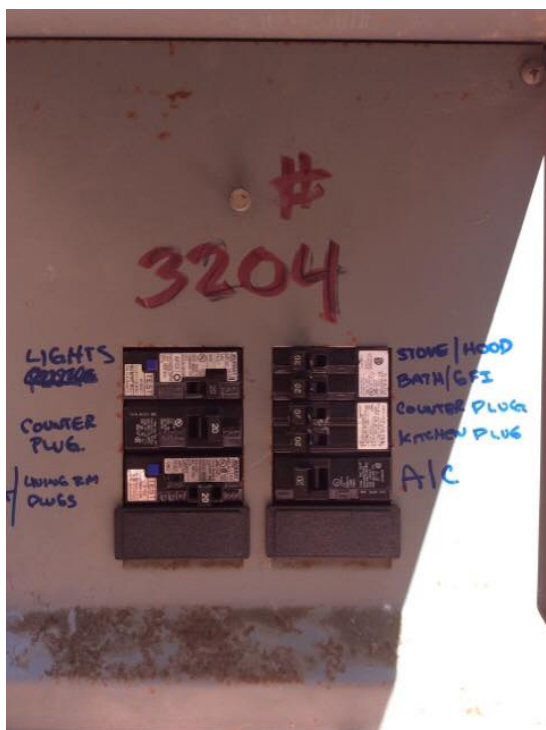
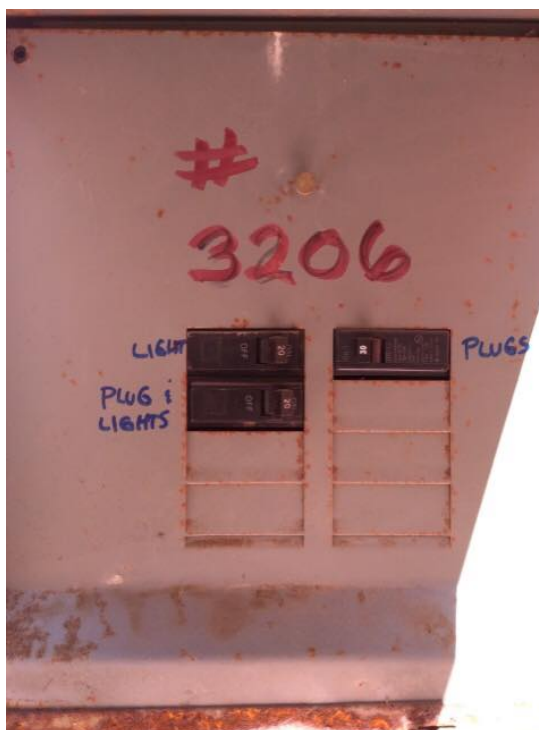
438: - Additional distribution panels, or subpanels, are located at the north wall

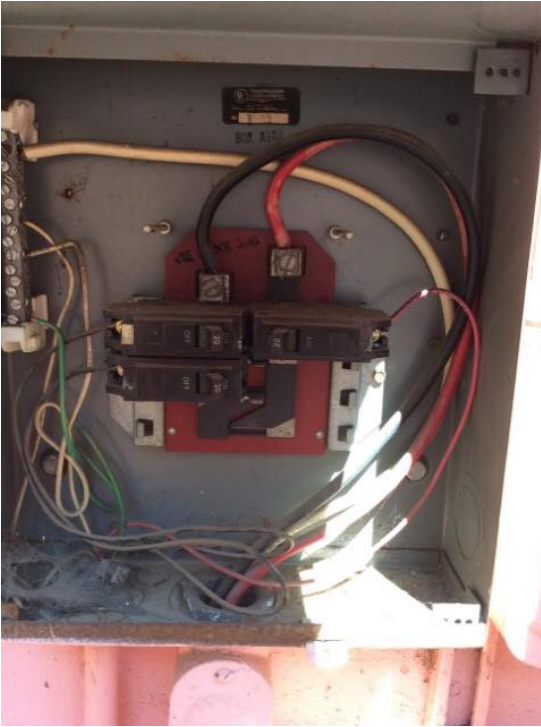
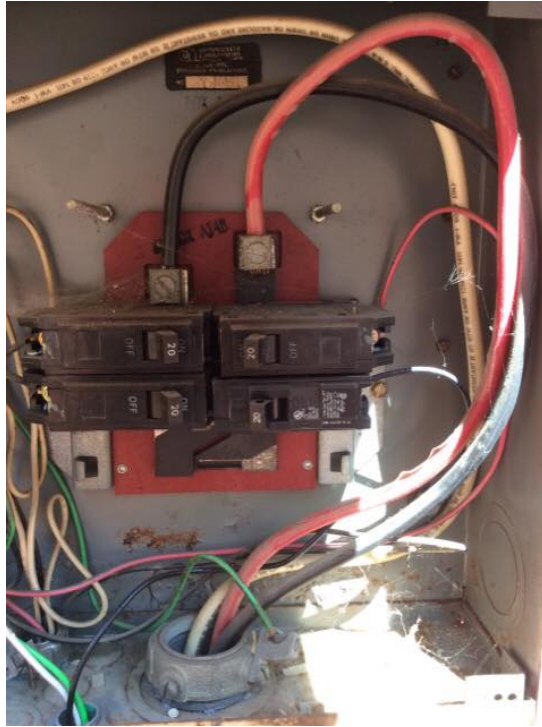
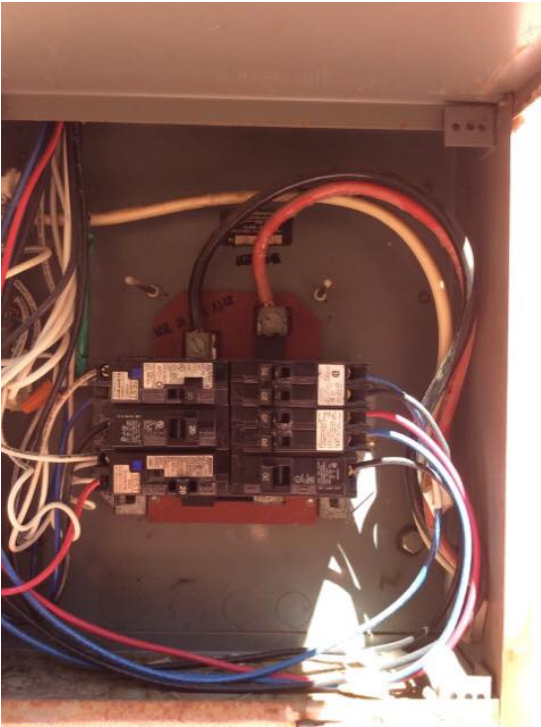
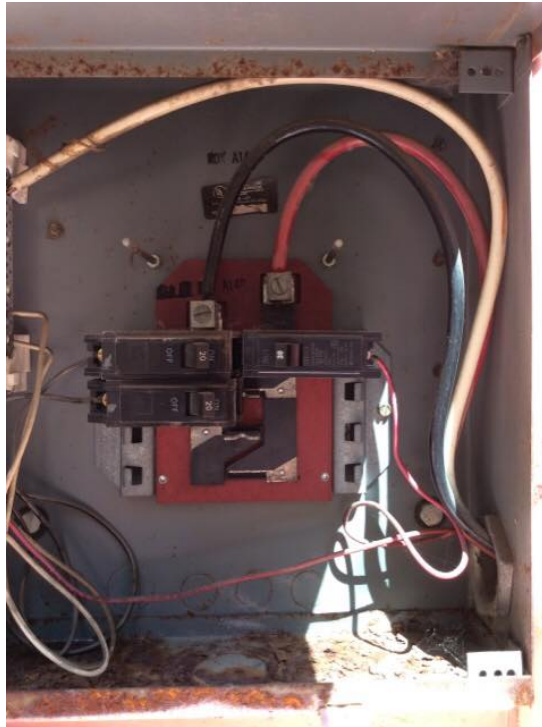
**439:** - The subpanels were opened and the inspected and circuitry was generally found to be installed and fused correctly, with exceptions noted below.

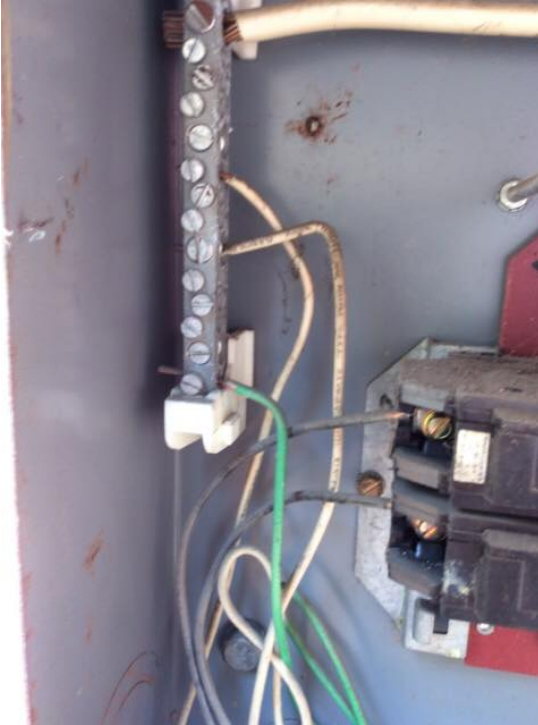
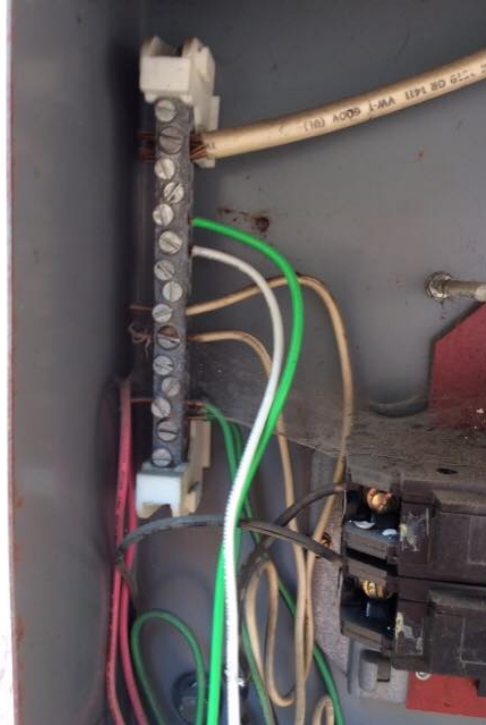
**440:** - The neutrals and the grounds are bonded together in the subpanel. This is not a permitted configuration because of a possible failure of the grounding system. We recommend the neutrals and the grounds be separated.

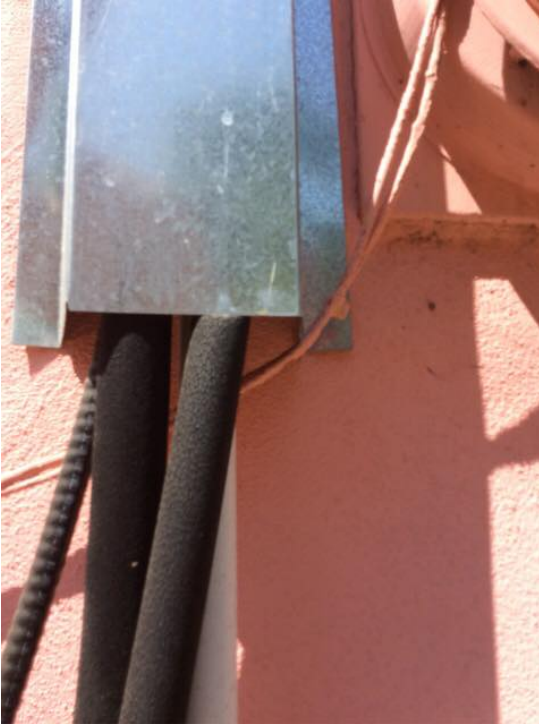
**519:** - The gap at the base of the metal chase should be sealed to prevent the intrusion of rodents into the home.

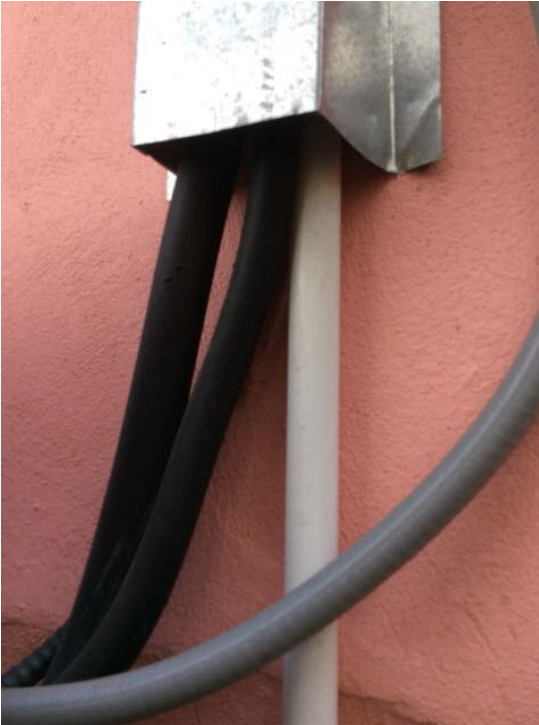
**534:** - The gap at the base of the metal chase should be sealed to prevent the intrusion of rodents into the home.

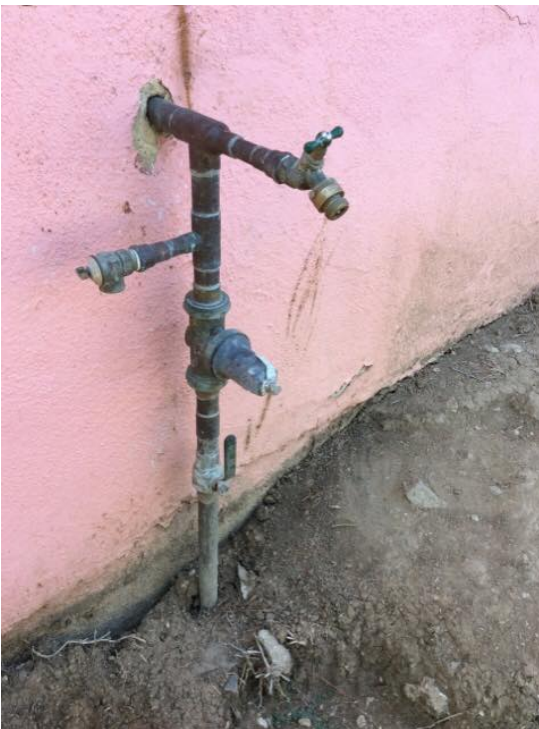
**1:** - The main water shut off is located at the North grounds.

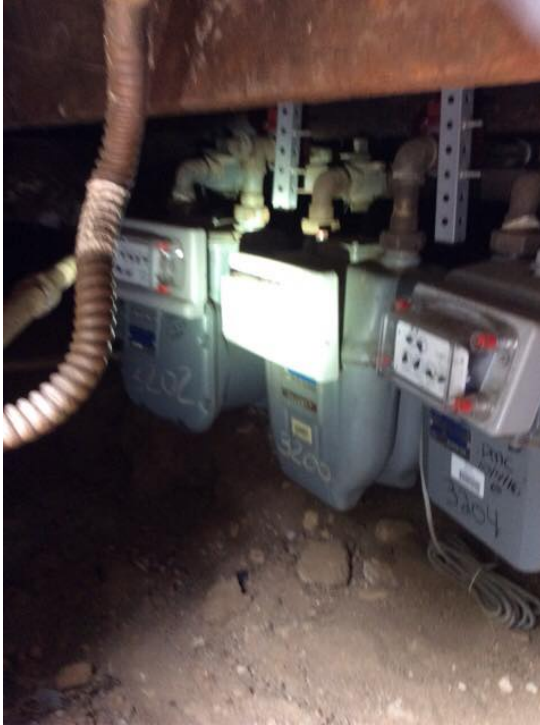
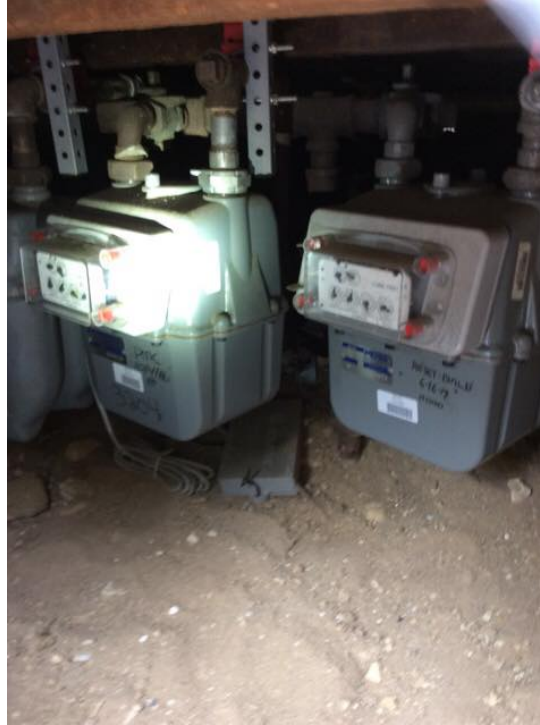
2: - The gas meter is in the crawl space. The location does not comply with current standards and is no longer a standard practice. However the condition may be permissible under the "Grandfather Clause". The main gas supply shutoff valve is located on the riser pipe between the ground and the meter. This valve should be turned 90 degrees (either way) in order to shut off the gas.
