# Confidential Inspection Report

LOCATED AT:  
3200 Larissa Dr.  
Los Angeles, CA 90026

INSPECTED ON:  
Wednesday, September 5, 2018

Inspector, Joe Bass  
Bass Building Inspection, Inc.

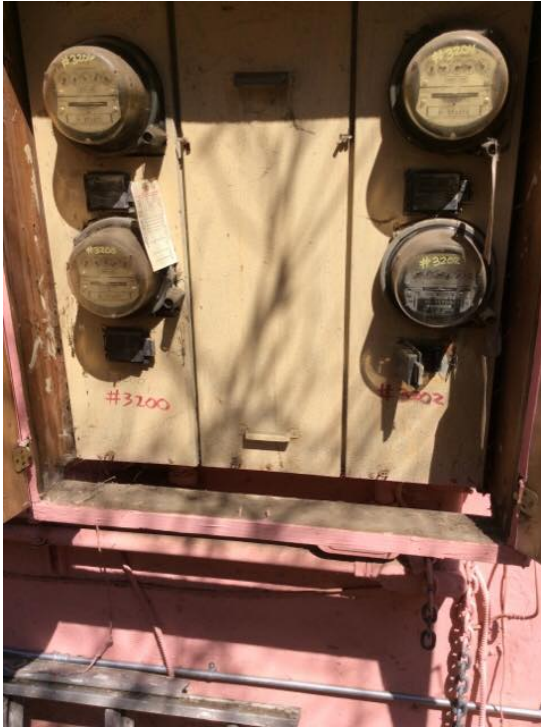
**3:** - The meter and main electrical service panel are located at the South wall.
